History Survey and Evaluation, Hypergol Module Processing South (M7-1212) and Boresight Control Building (M7-0867)

John F. Kennedy Space Center, Brevard County, Florida

April 6, 2012 • **Final Report**
New South Associates Technical Report 2035

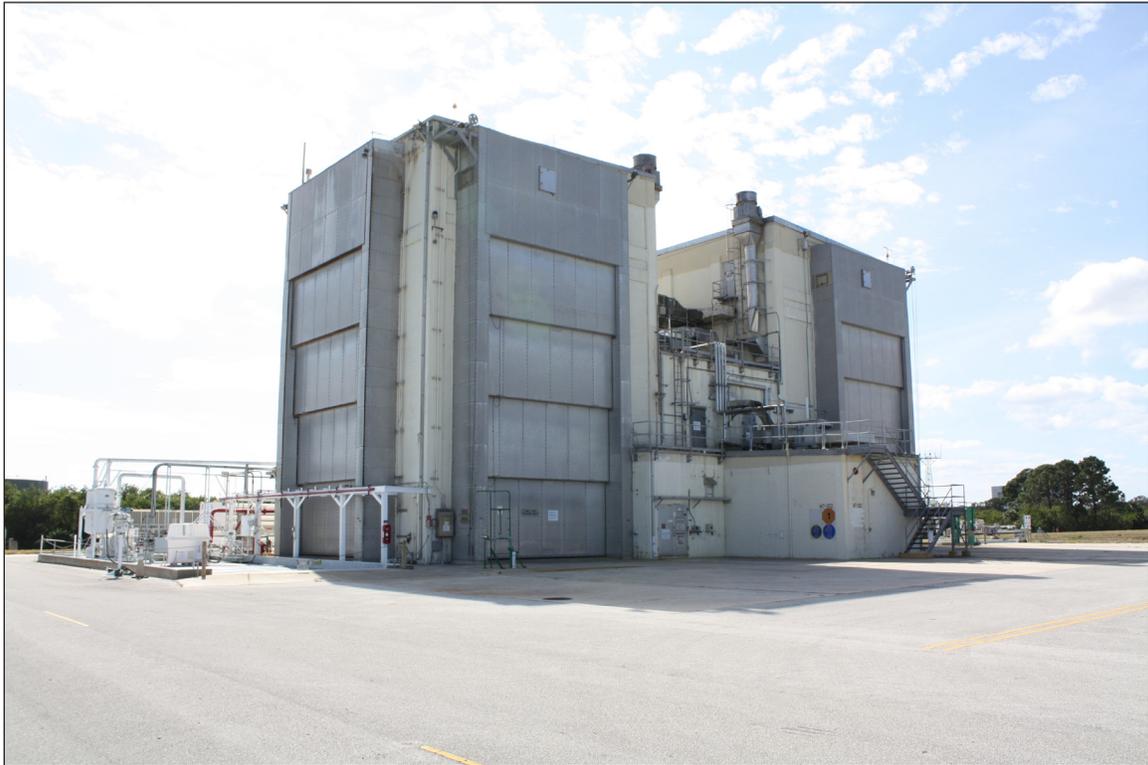
Figure 2.
Hypergol Module Processing South (M7-1212)

HMP South (8BR2933) is a concrete block building with a reinforced concrete foundation. The building has an irregular footprint that contains 7,100 square feet of floor area. It has two high-bay test cells, one on the east side and one on the west side, which measure approximately 40x40x60 feet. Each cell features two vertical-lift exterior doors that measure 22x40 feet and are equipped with inflatable seals for excluding contaminants. Each test cell has a 10-ton overhead bridge crane with a hook height of 45 feet. Both cells have a large capacity exhaust system and a floor system that collects and dilutes hypergolic spills. Between the test cells is a two-story central area that contains a control room, equipment room, and storage area (NASA 1967:10-55) (Figure 2).

On the south side of HMP South's exterior are chilled water storage tanks and basins, compressed air tanks, gaseous nitrogen/helium tanks, washdown systems, and a contaminated effluent tank to control and contain inadvertent spilling of toxic and combustible propellants.

A. Exterior Oblique, View Southwest

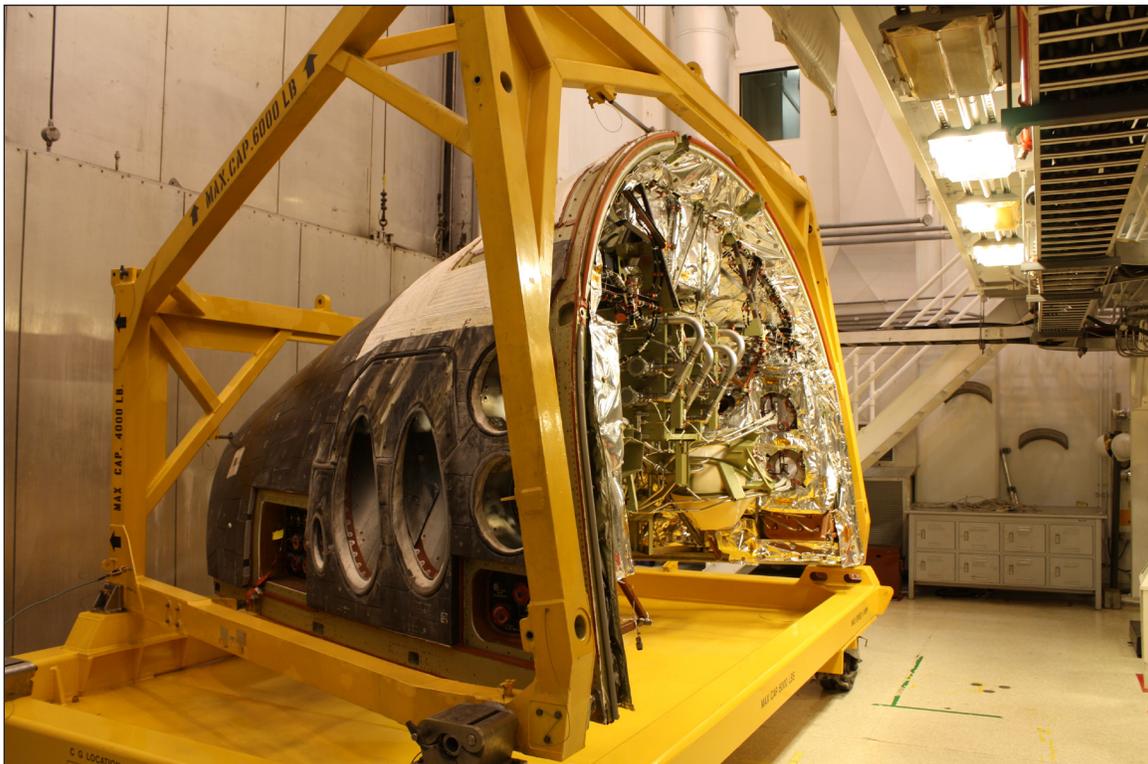
The interiors of HMP South's test cells contain hypergolic fuel and oxidizer servicing areas that are capable of testing and servicing the Space Shuttle's forward RCS. The east test cell contains three levels of work platforms arranged in a U-shape around the outer walls. This cell was used primarily as a staging area or auxiliary test space, with the west test cell reserved as the primary area for forward OMS module processing. The west test cell contains a two-level work area. The ground level has an OMS module staging area and all of the hypergolic fuel and oxidizer pumps, lines, and gauges. Above this ground level is a steel-frame upper level work platform. The overhead bridge crane lifted the OMS module up onto this platform where it was maneuvered into different positions depending on the work performed.

B. Interior Test Cell with Forward RCS Module, View Northwest

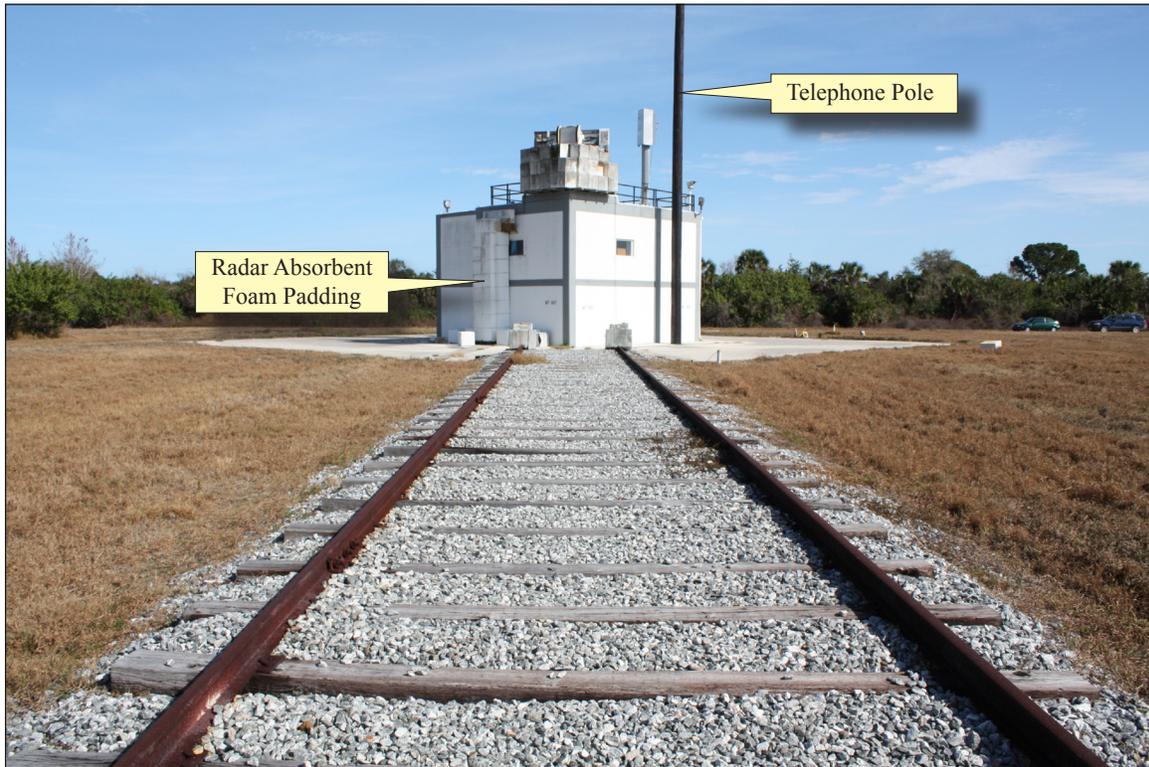
Figure 3.
Boresight Control Building

It is a two-story building with a concrete block structure and reinforced concrete foundation. The block-shaped building measures 20x20x20 feet. There is a mechanical room on the first floor, a control room on the second floor, and a pedestal on the roof for mounting a test antenna. There is also a crane on the roof for lifting equipment from the ground surface (NASA 1974:10-67). There are two fixed single-light windows on the building's second story that face west toward the antenna range. Extending west is a railroad track, approximately 400 feet long, equipped with a movable radar test tower. This track and tower were installed circa 1986 when the building was refurbished for the Space Shuttle Program. Adjacent to the southwest elevation is a telephone pole (Figure 3).

A. West Corner of Building Facing Boresight Range, Oblique View East

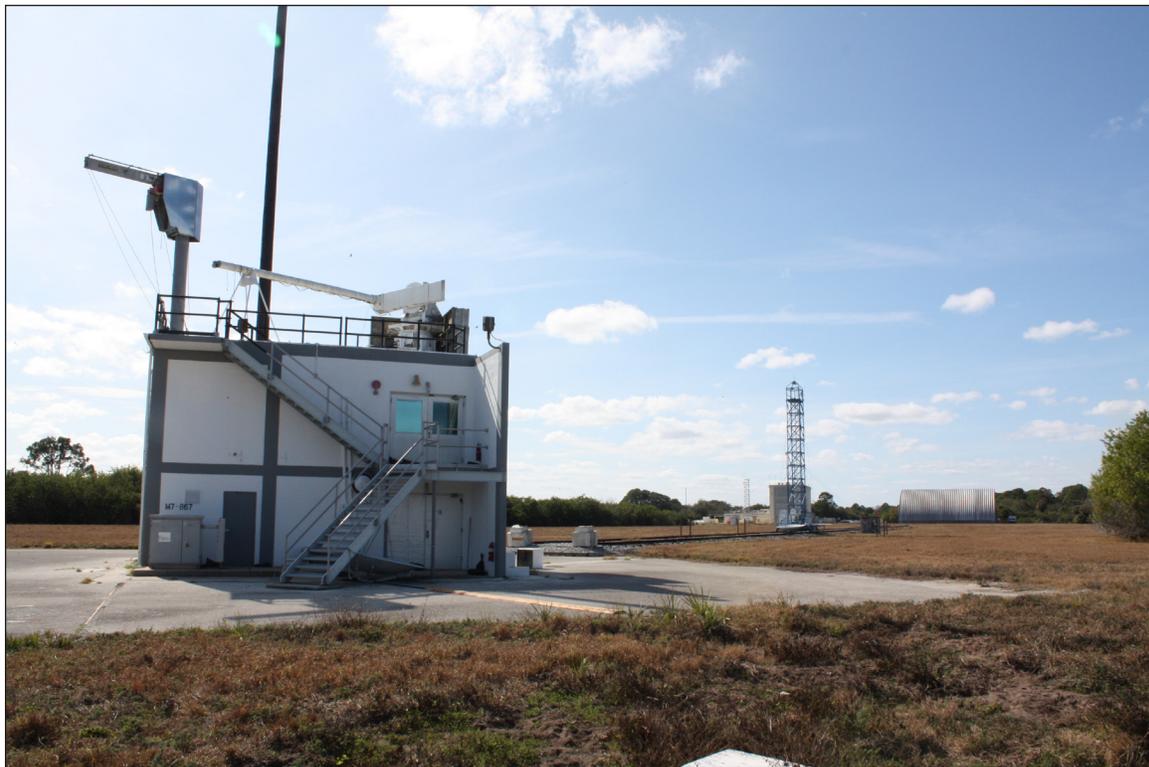
The building is accessed via double pedestrian doors on the northeast elevation at the ground and/or second level. There is a single pedestrian door on the ground level of the southeast elevation. The northeast elevation also has a two-story steel staircase that leads to the second floor entrance and to the roof. The staircase is shielded on its north side by an approximately 5x20-foot wing wall. The perimeter of the roof is lined by a metal safety railing. The west end of the test antenna on the roof is shielded by blocks of radar absorbent foam padding in deteriorated condition. Similar absorbent foam padding is stacked in a column on the northwest elevation (Figure 3).

B. Rear (Northeast) Elevation of the Boresight Control Building and Movable Radar Tower, View Southwest

The most recent renovation of the building occurred in 2006. Repairs were made to the roof and the exterior and control room walls were also painted. Other repairs completed were installation of new windows, a new roof crane, new radar absorbent padding, and new computer and equipment systems (Sarosi 2012).

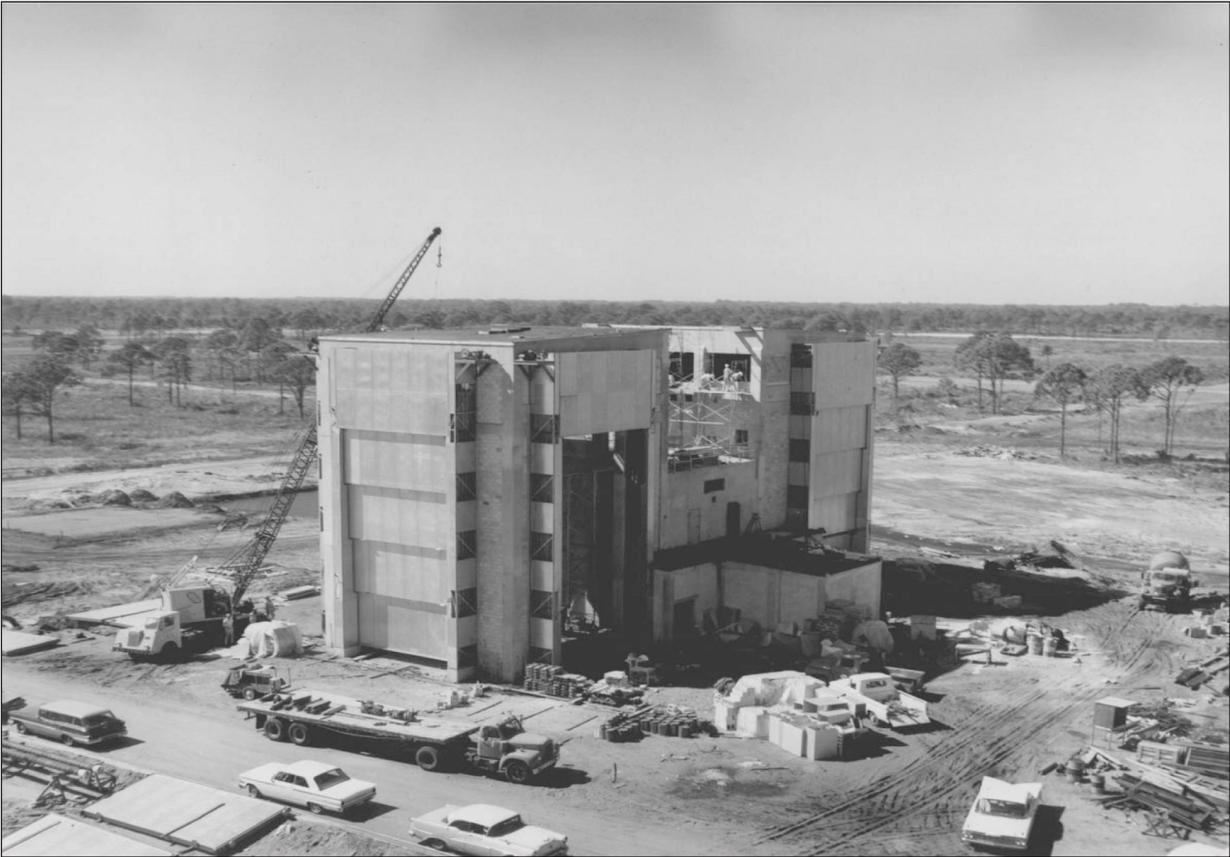
Figure 4.
Historic Aerial Photograph Showing HMP South Under Construction, 1963

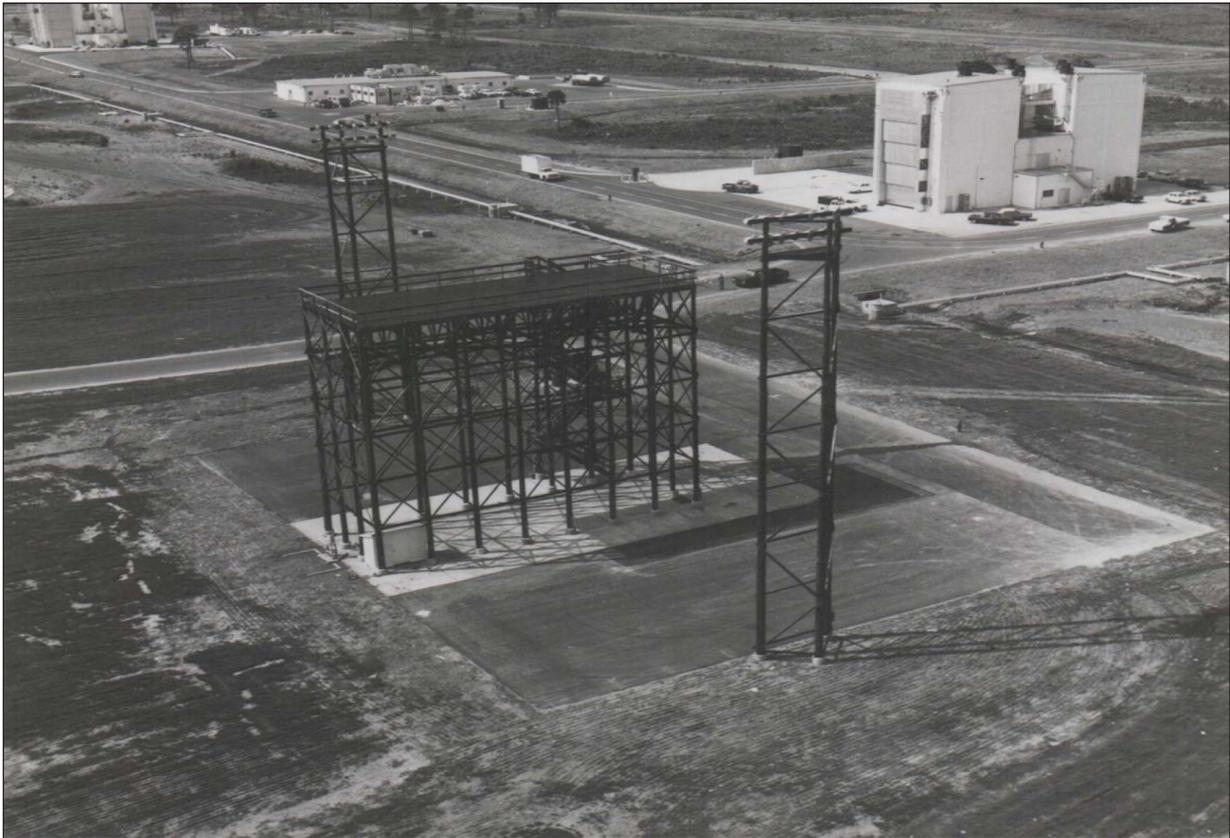
The Boresight Control Building was built on March 3, 1963, as part of a larger area called the Radar Boresight Range that tested the radiating capabilities and characteristics of antenna systems used on the Gemini spacecraft and Agena target vehicle. In addition to the Boresight Control Building, the Radar Boresight Range originally included the wooden Boresight Tower on its west end that measured 64x24x50 feet (Figure 5). Informally known as the “timber tower,” it provided a platform for testing radar equipment from the control room in the Boresight Control Building. The tower was demolished in the 1980s due to its deterioration into a safety hazard. Between the Boresight Control Building and tower is the former 1,000x200-foot graded area that provided a controlled reflective surface for radar boresight testing (J-BOSC Environmental Health and Services 2004).

Figure 5.
Historic Aerial Photograph Showing Boresight Tower, 1963

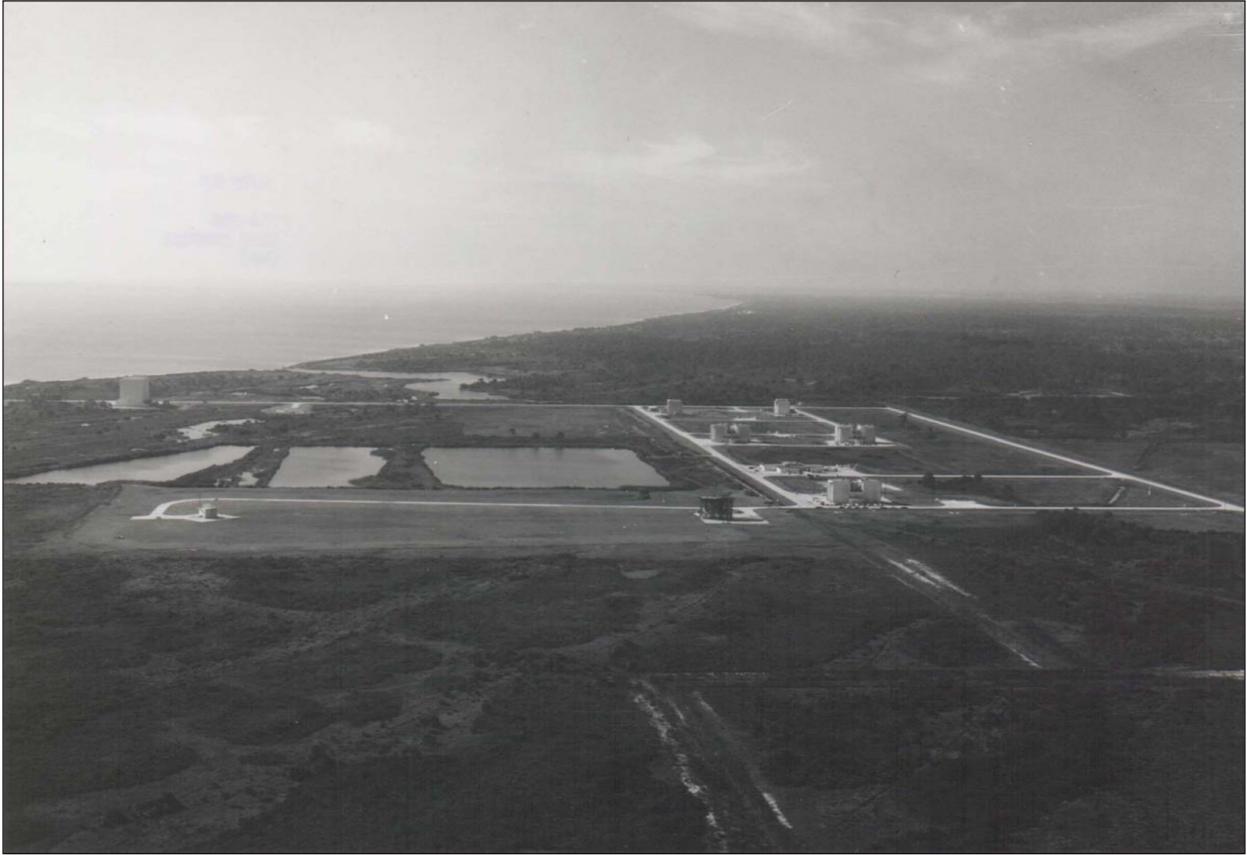
The Radar Boresight Range was initially constructed to support the Gemini (1962-1966) program. It was also used by the Apollo (1968-1972) program and was then modified to support the Spaceflight Tracking and Data Network Station (STDNS). The range and its equipment were designed and furnished by Scientific-Atlanta, Inc., a company that represented the state-of-the-art ground-level antenna testing at that time. According to a 1963 NASA procurement memorandum, there were only two other existing ground level antenna ranges of this type that offered the required levels of sensitivity, accuracy, dynamic range, and operational integrity. The memorandum does not state where these two other antenna ranges were located (Eiband 1963) (Figure 6).

Figure 6.
Historic Aerial Photograph of the HMCA Historic District
and Radar Boresight Range, 1969

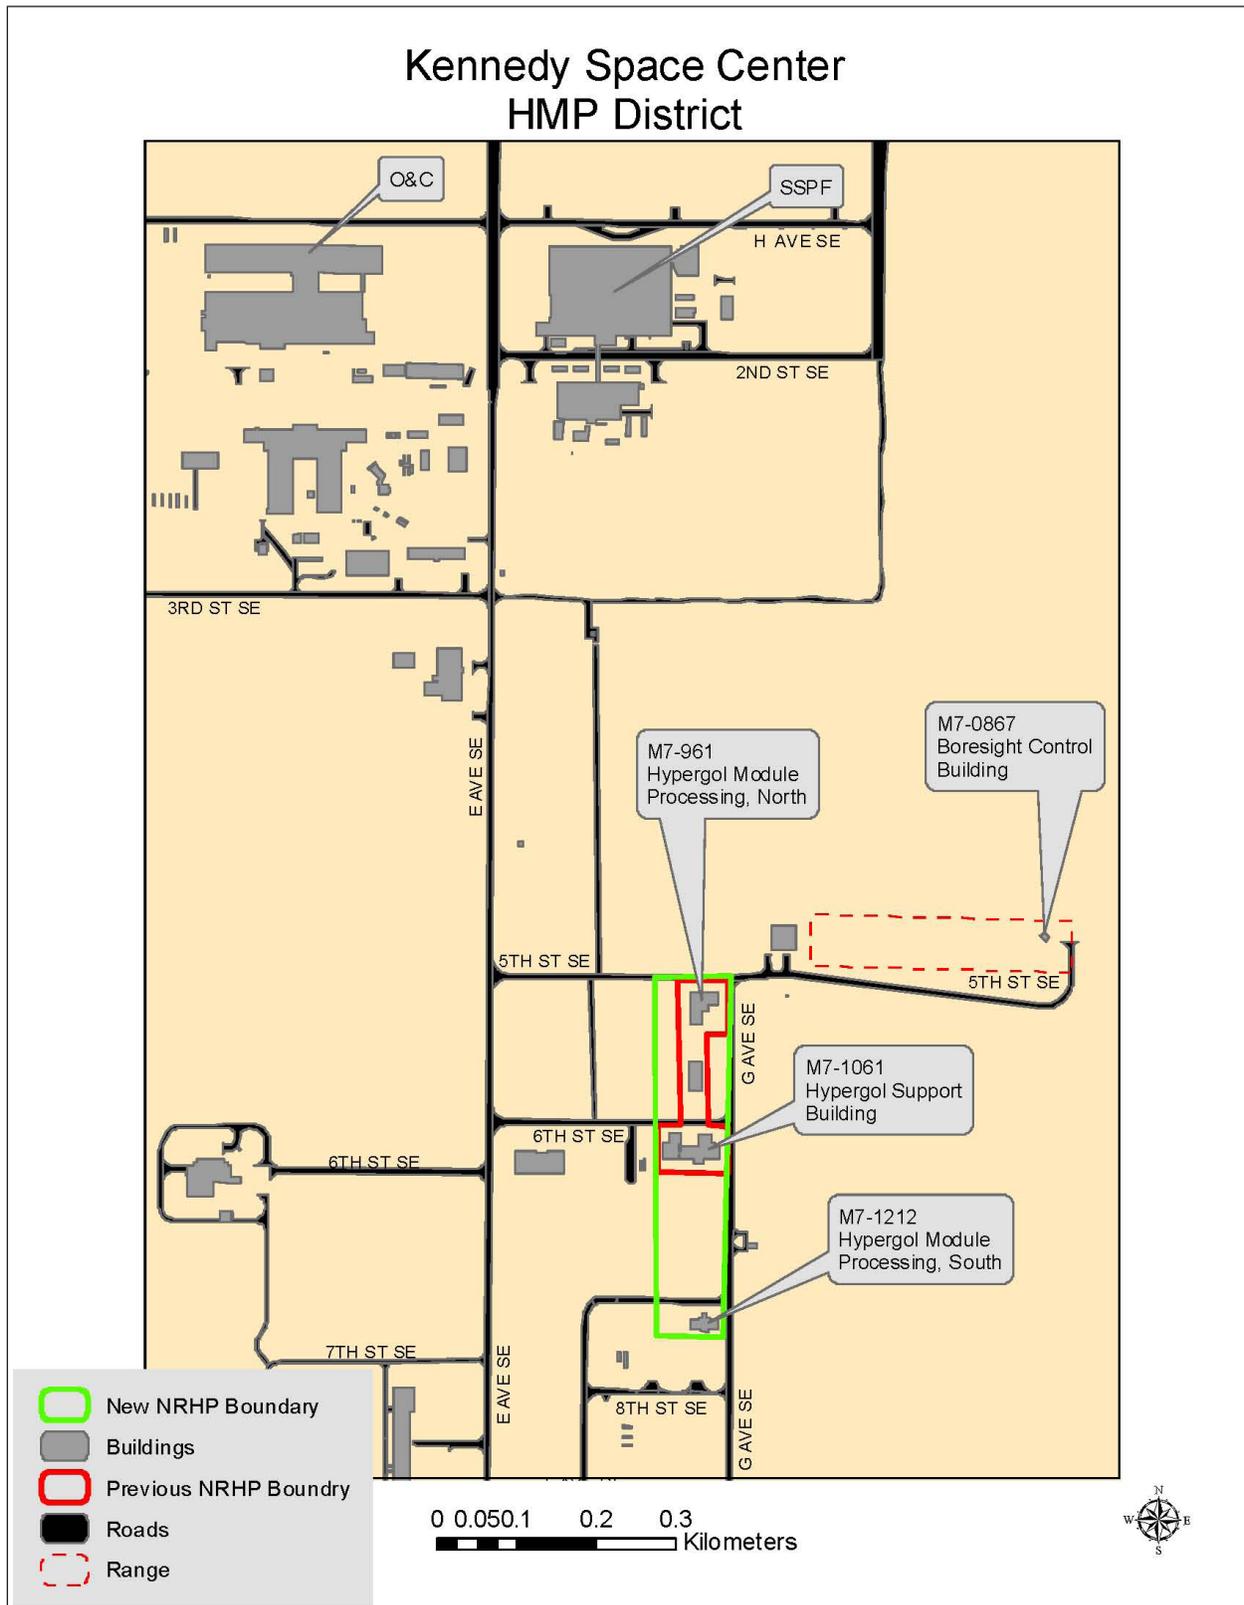
HMP South is located across a wooded area directly south of the existing HMCA Historic District. It is recommended that the property be included in district's boundary; therefore, the boundary must be extended to the south approximately 750 feet. The boundaries do not need to be expanded in any other direction. This boundary expansion will add approximately 4.5 acres to the historic district (Figure 7).

Figure 7.
HMCA Historic District Boundary Expansion
