CAPE CANAVERAL AIR FORCE STATION,  
LAUNCH COMPLEX 39,  
SOLID ROCKET BOOSTER ASSEMBLY AND REFURBISHMENT FACILITY  
MANUFACTURING BUILDING  
(SRB ARF MANUFACTURING BUILDING)  
(John F. Kennedy Space Center)  
Cape Canaveral  
Brevard County  
Florida

HAER FL-8-11-R

WRITTEN HISTORICAL AND DESCRIPTIVE DATA

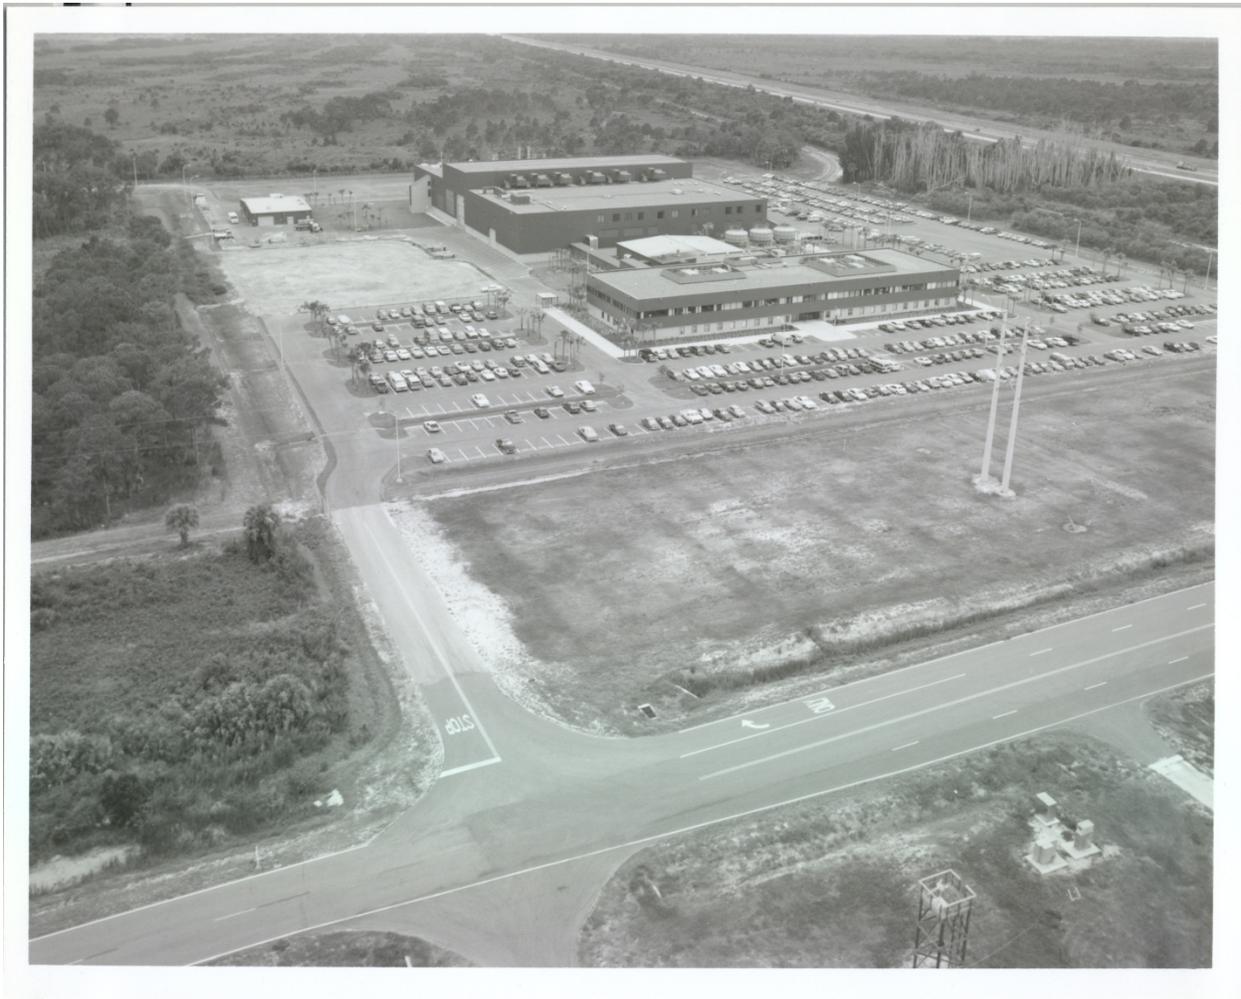
Aerial photograph of the SRB ARF Manufacturing Building, View Southwest, 1987. (Courtesy KSC, Image KSC-87PC-769).

Although KSC added new buildings to the ARF Complex after its original 1986 construction, the ARF Manufacturing Building retains its original appearance. Examinations of the building's original construction drawings and a 1987 aerial photograph show that the building has had no major exterior alterations or additions. The interior floor plan and finish materials also remain intact. A full architectural description is found in Part II of this document.
