ADDENDUM TO:
CAPE CANAVERAL AIR FORCE STATION, LAUNCH COMPLEX 39,
OPERATIONS AND CHECKOUT BUILDING
(John F. Kennedy Space Center)
First Street, between Avenue D and Avenue E
Cape Canaveral
Brevard County
Florida

HAER No. FL-8-11-E

CAPE CANAVERAL AIR FORCE STATION, LAUNCH COMPLEX 39,
OPERATIONS & CHECKOUT BUILDING
(John F. Kennedy Space Center)
HAER No. FL-8-11-E, ADDENDUM

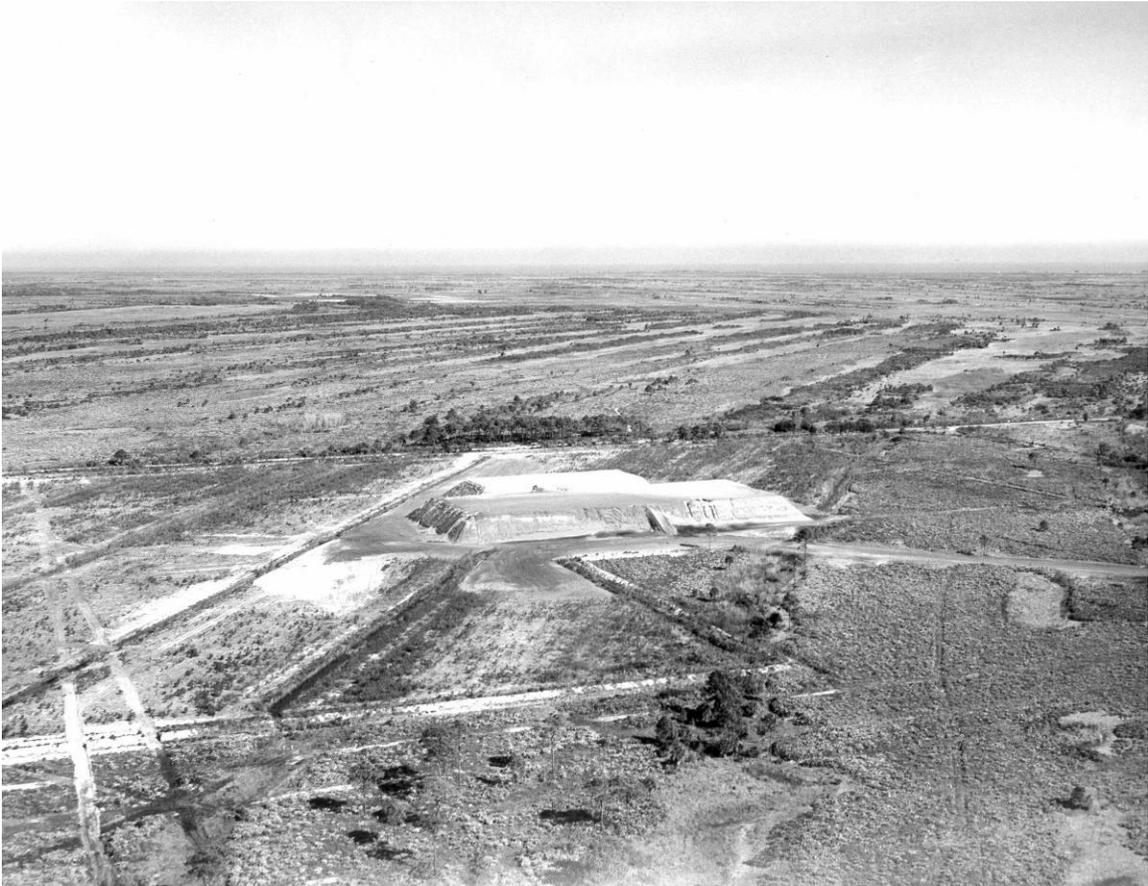
Figure B-1. View of surcharge used to compact soil underneath the O&C Building foundation, facing northeast, December 11, 1962.

The ACOE, NASA's supervisory design and construction agent, hired Burns and Roe, Inc. to complete the design for the O&C Building, which at one time was referred to as the Manned Spacecraft Operations Building.⁶ Preliminary groundwork for the facility was completed by the Azzarelli Construction Company, of Tampa, Florida, in November 1962. Part of this work included piling 200,000 cubic feet of soil on the site to compact the shale, fine sand, and clay silt earth in order to form a stable foundation for the building (Figure B-1).⁷

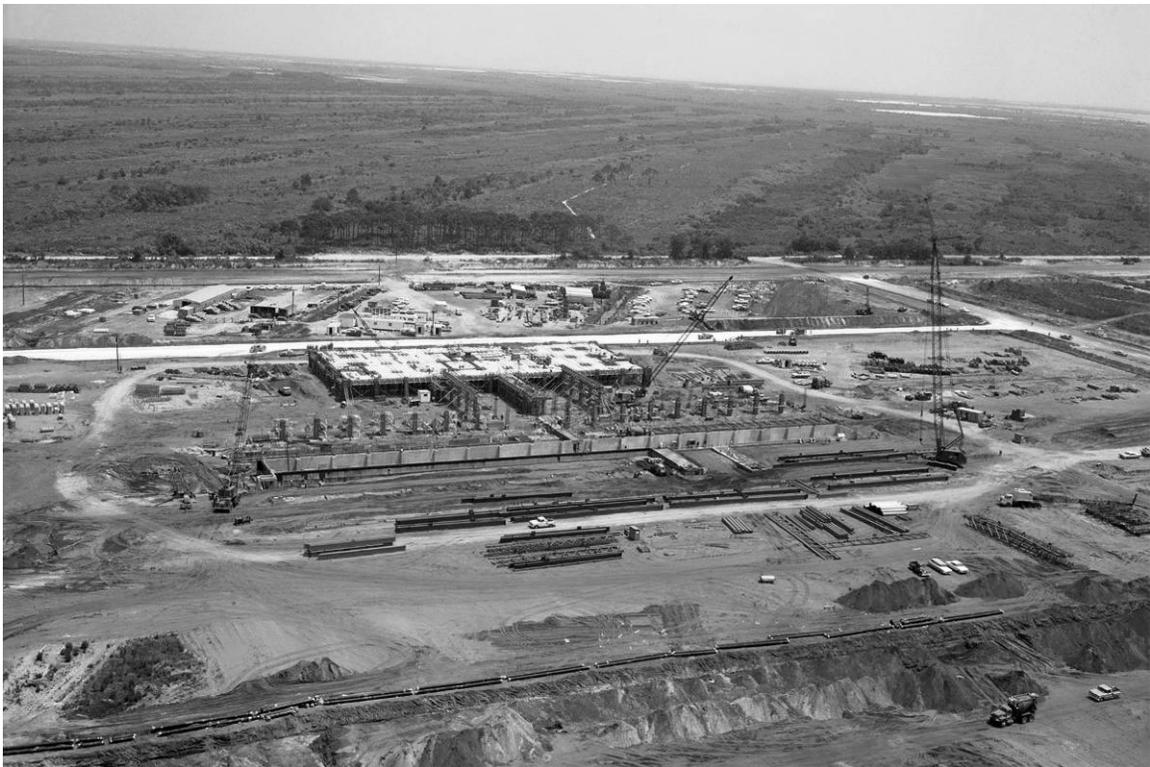
Figure B-2. Early construction of the O&C Building, facing northeast, May 17, 1963.
Source: Kennedy Institutional Imaging Facility, KSC-63C-1682.

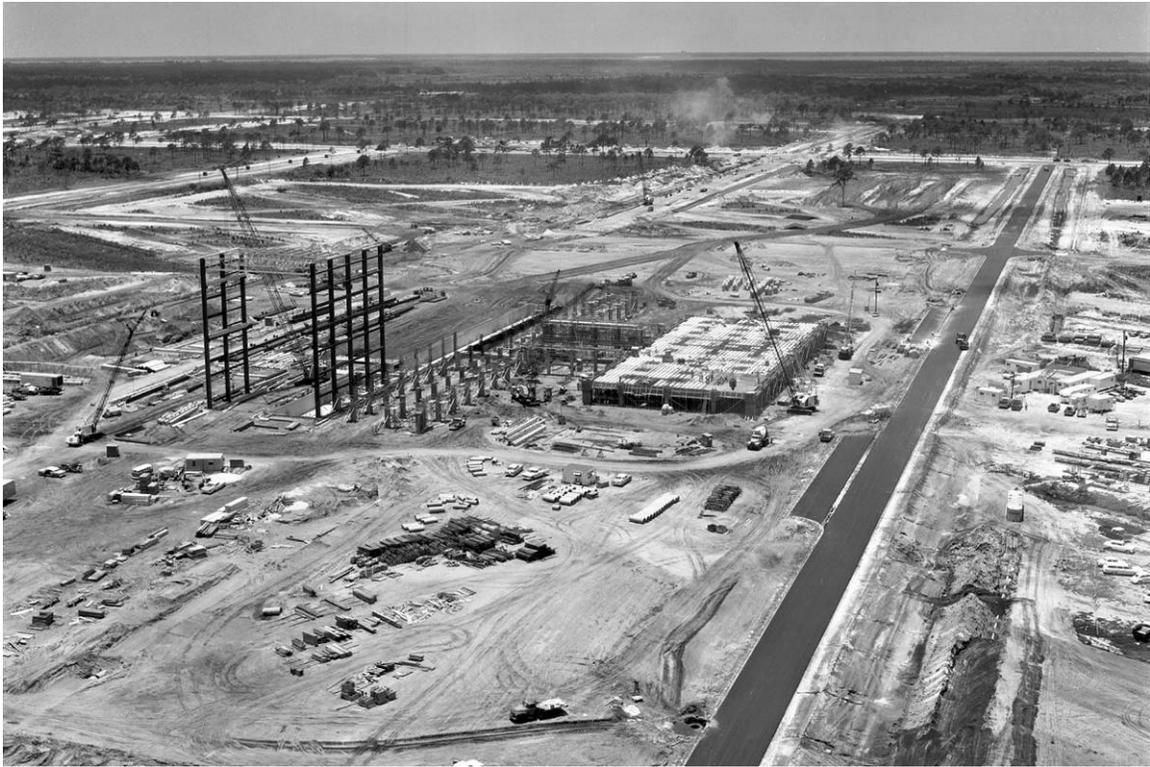
Figure B-3. Aerial showing early construction of O&C Building, facing southwest, June 4, 1963.
Source: John F. Kennedy Space Center Archives, LOC-63-5667.

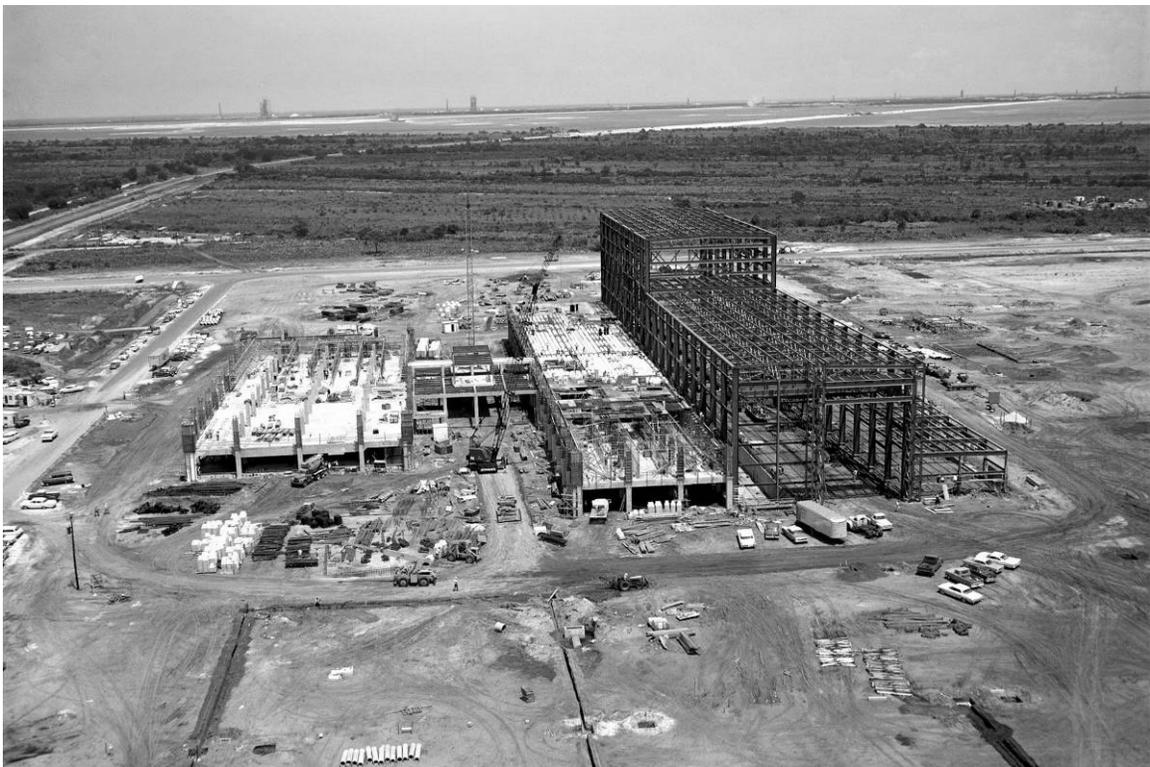
Figure B-4. Construction of the O&C Building, facing east, July 29, 1963.
Source: Kennedy Institutional Imaging Facility, KSC-63C-2376.

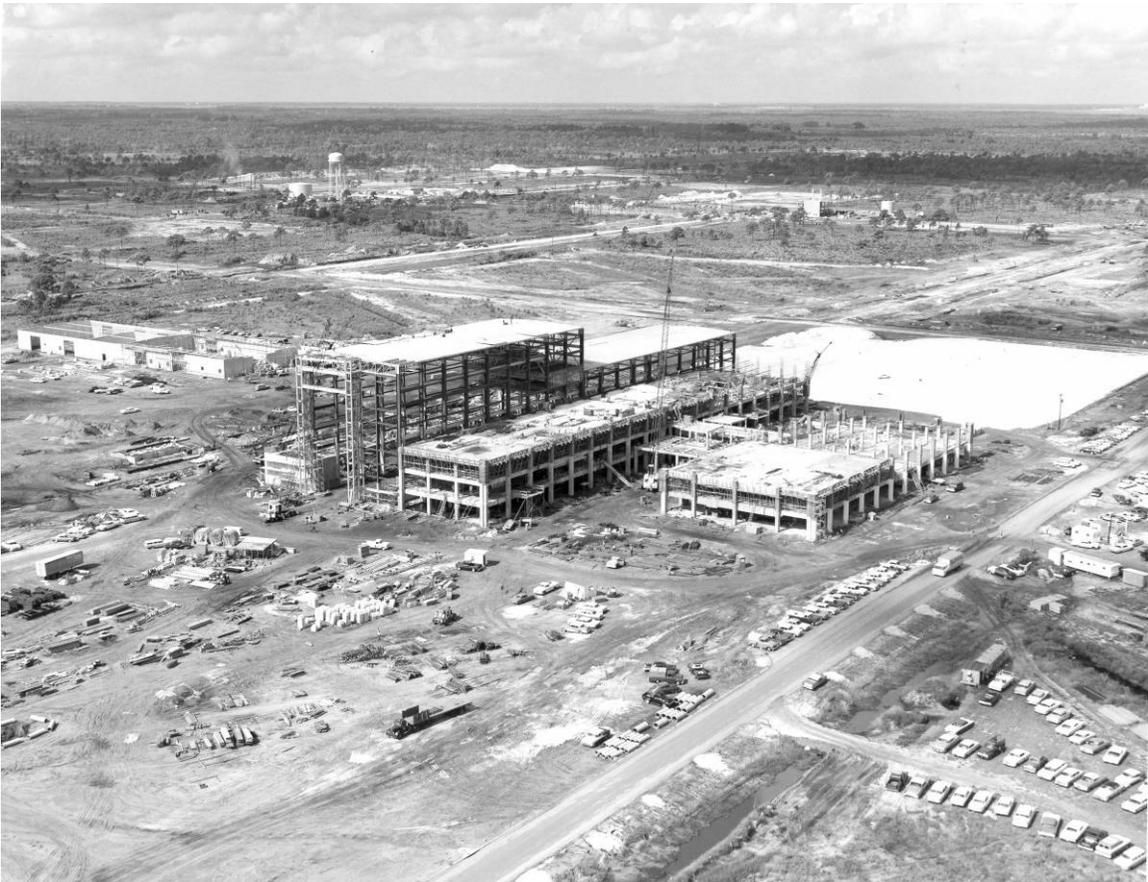
Figure B-5. Construction of the O&C Building, facing southwest, August 27, 1963.
Source: John F. Kennedy Space Center Archives, LOC-63-8557.

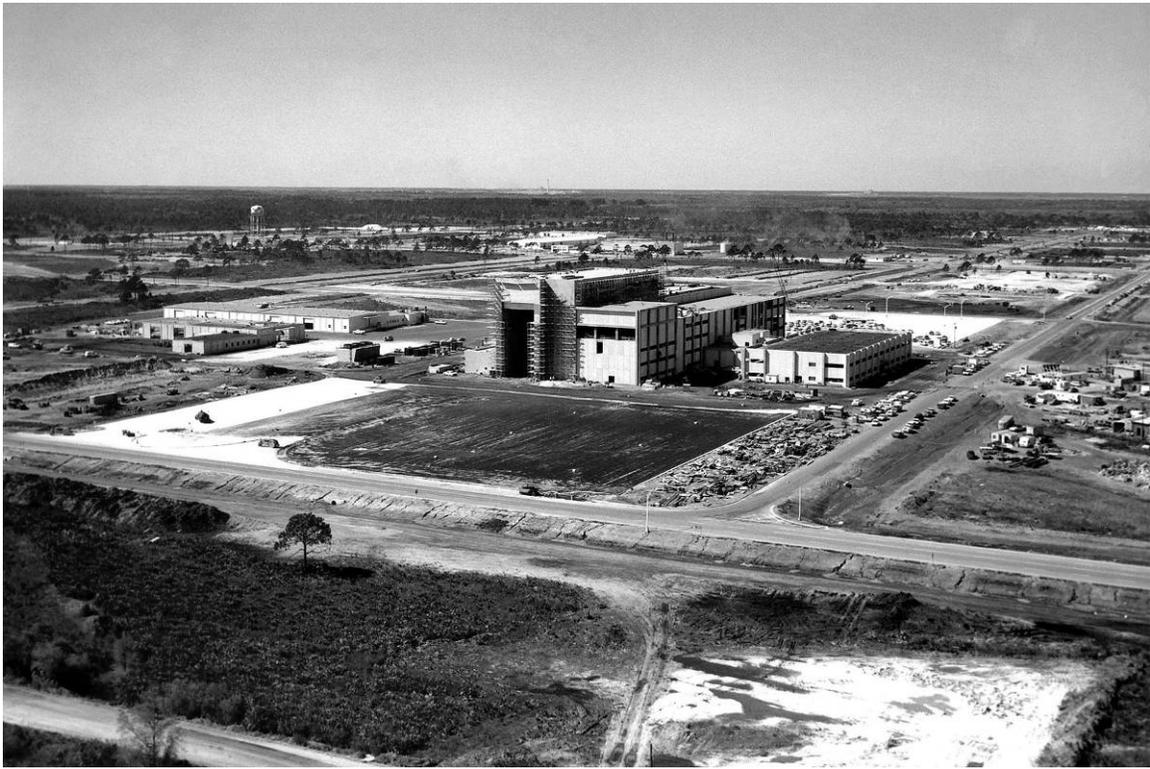
Figure B-6. Construction of the O&C Building, facing southwest, 1964.
Source: Kennedy Institutional Imaging Facility, KSC-64C-1712.

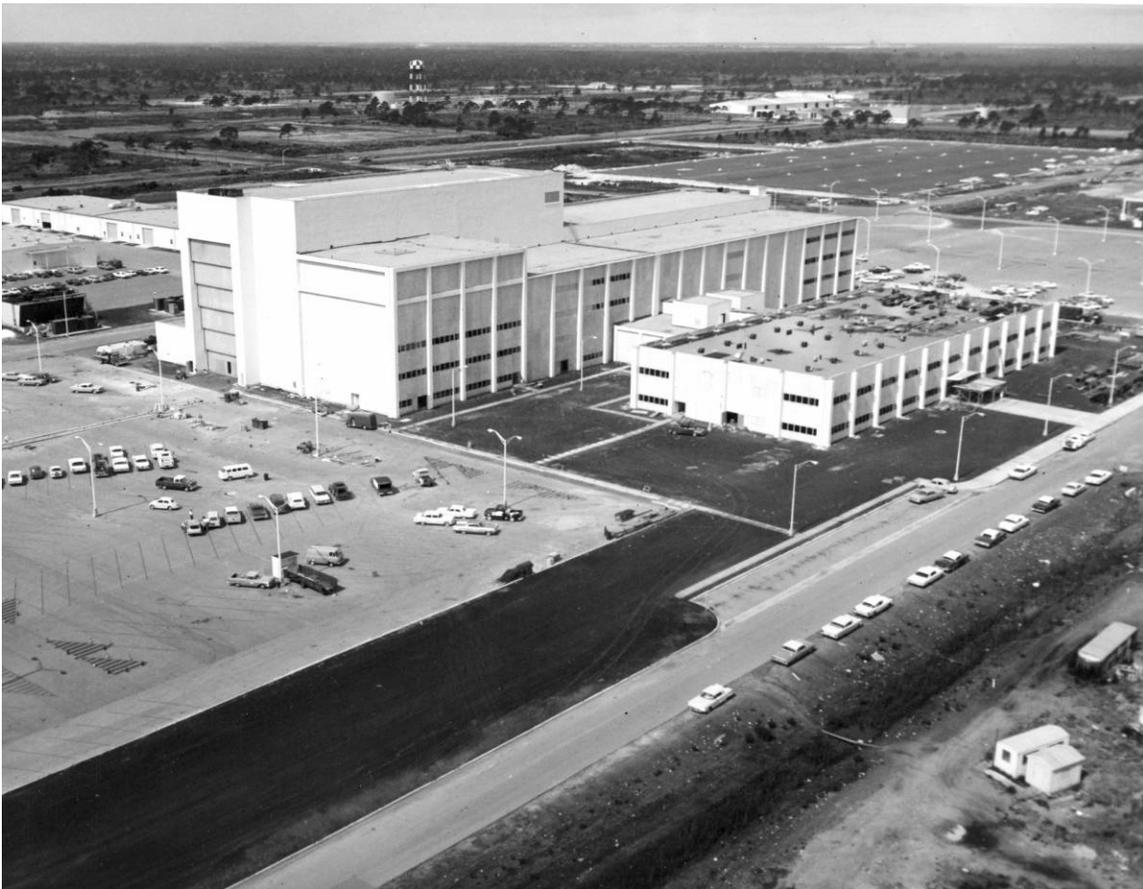
Figure B-7. Construction of the original O&C Building nearing completion, facing southwest,
June 25, 1964.

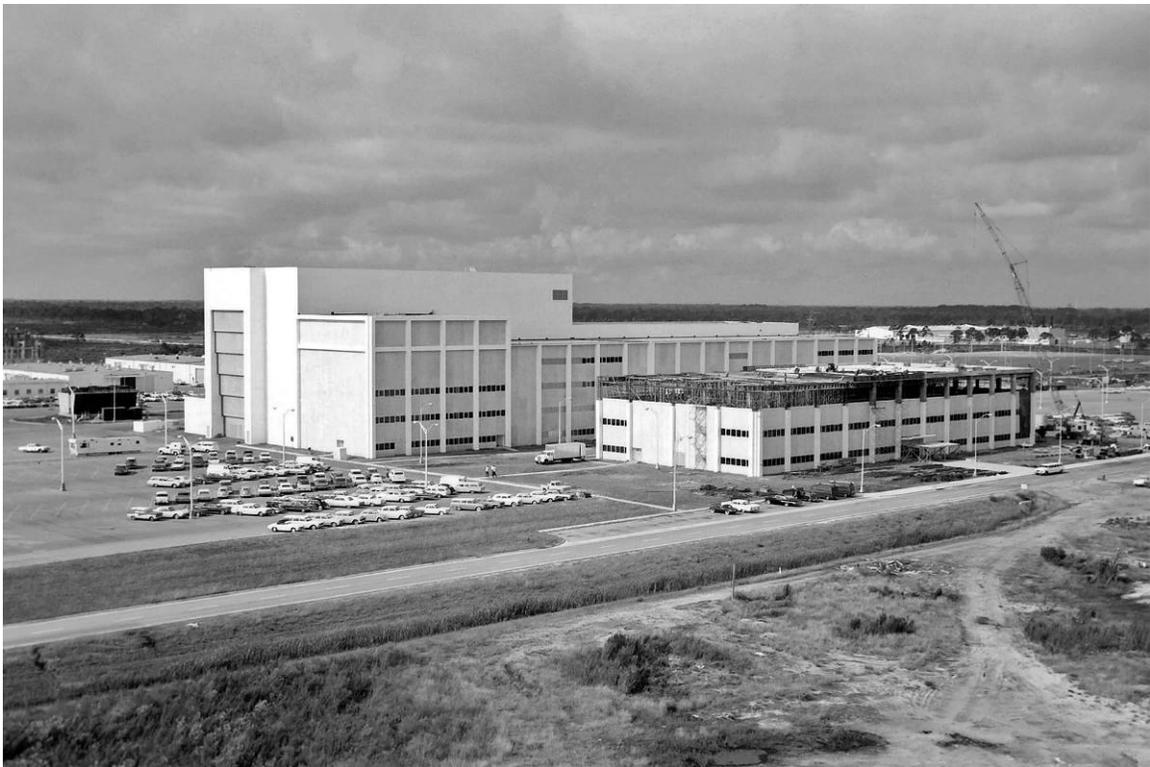
Figure B-8. Construction of the third floor of the O&C Building north wing, facing southwest, September 3, 1964.

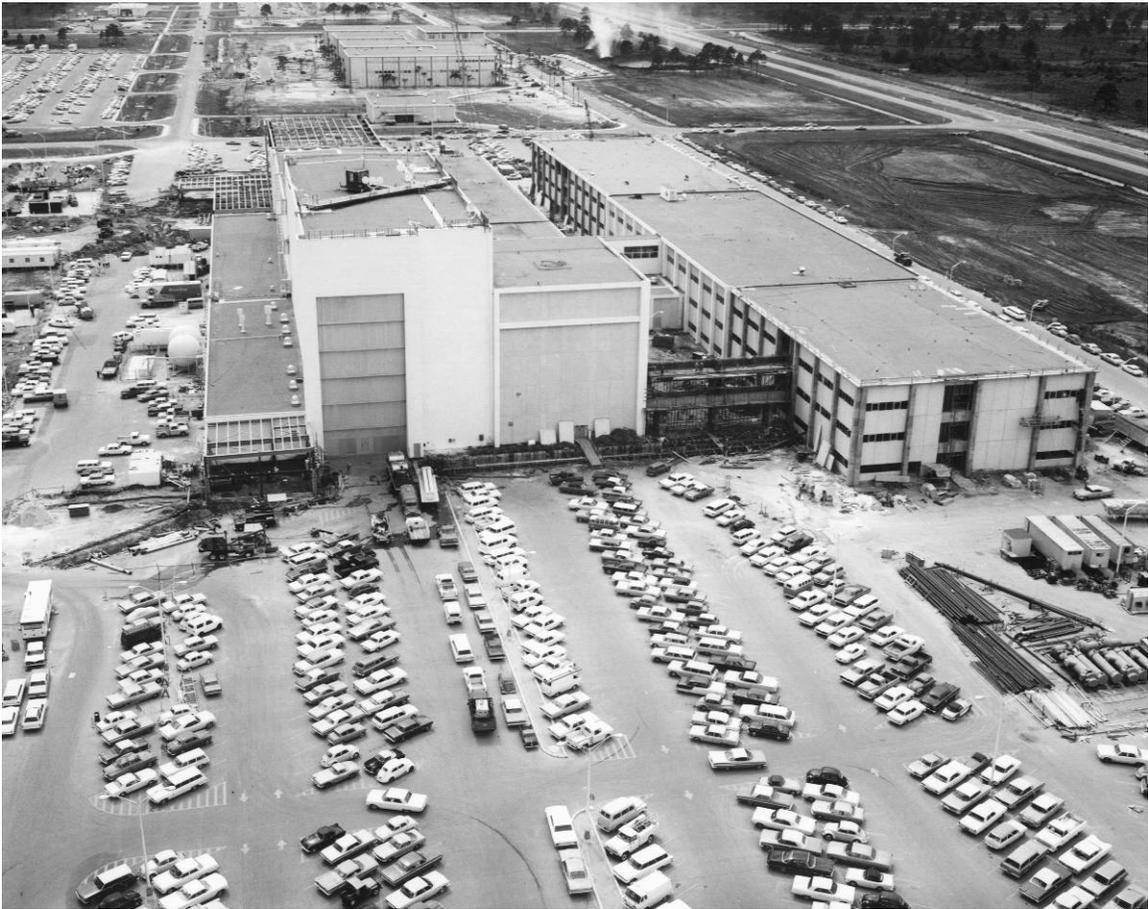
Figure B-9. Construction of the east and west additions to the O&C Building, facing west-northwest, August 5, 1965.

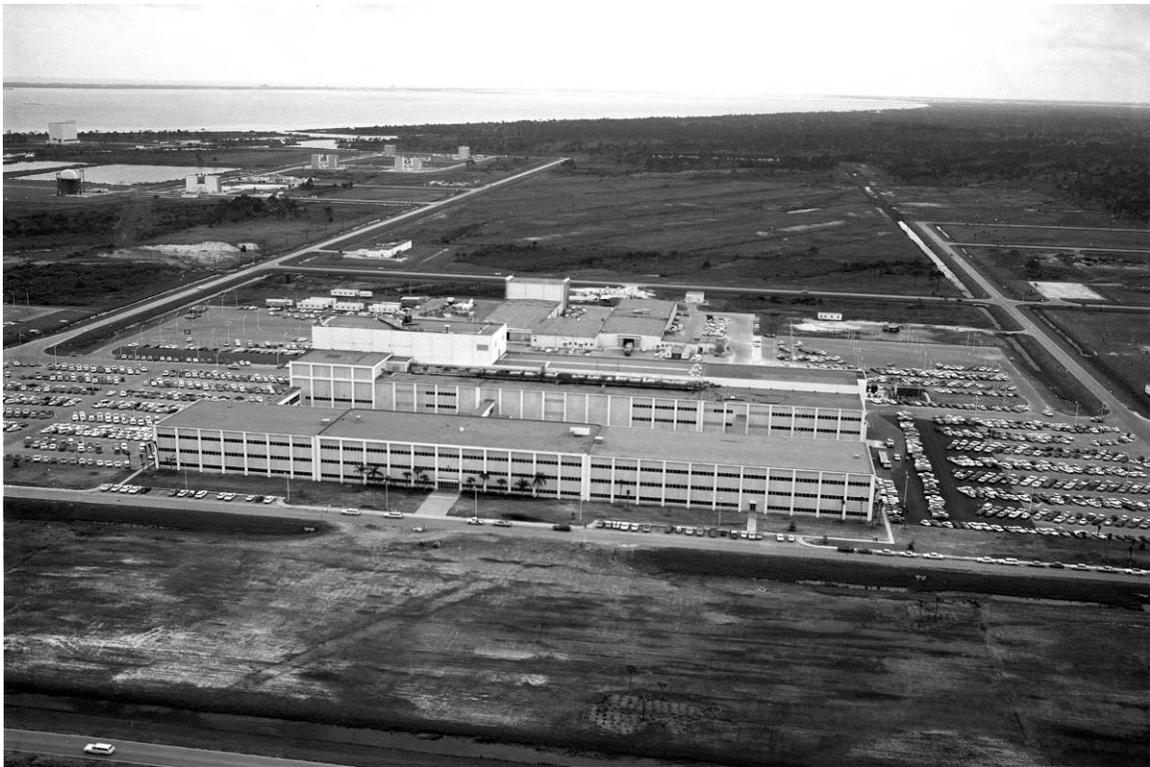
Figure B-10. Aerial of the O&C Building with the completed exterior shells of the additions, facing south, June 21, 1966.

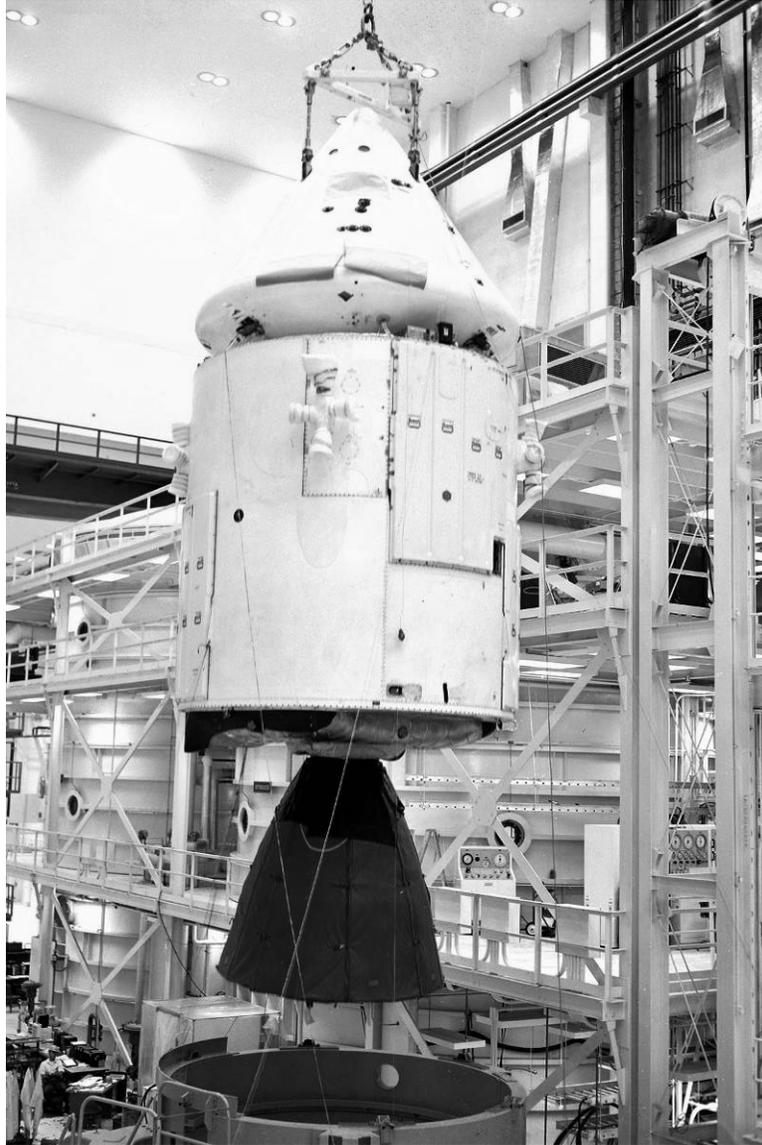
Figure B-11. Apollo command and service modules being hoisted for mating, facing northwest,
June 25, 1966.

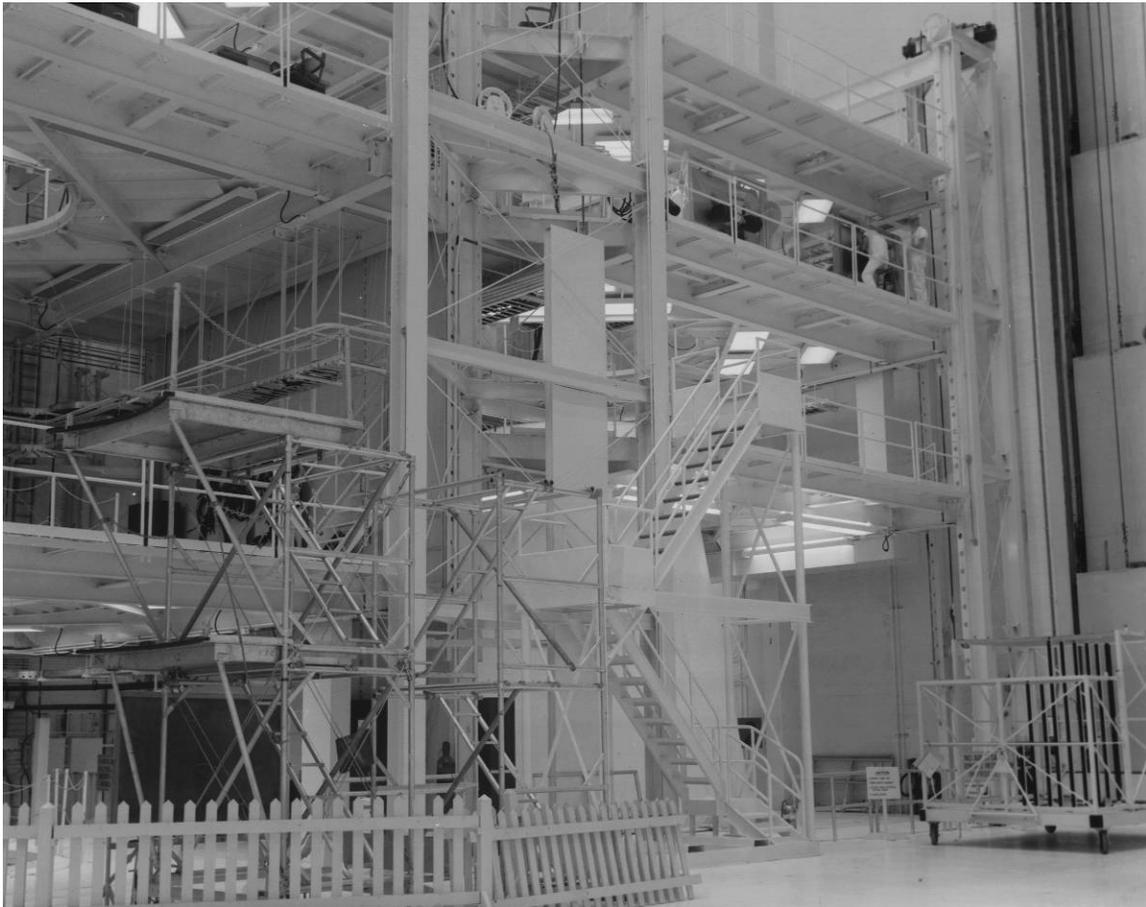
Figure B-12. Construction of the Lunar Module assembly and test area, facing northeast,
August 15, 1966.

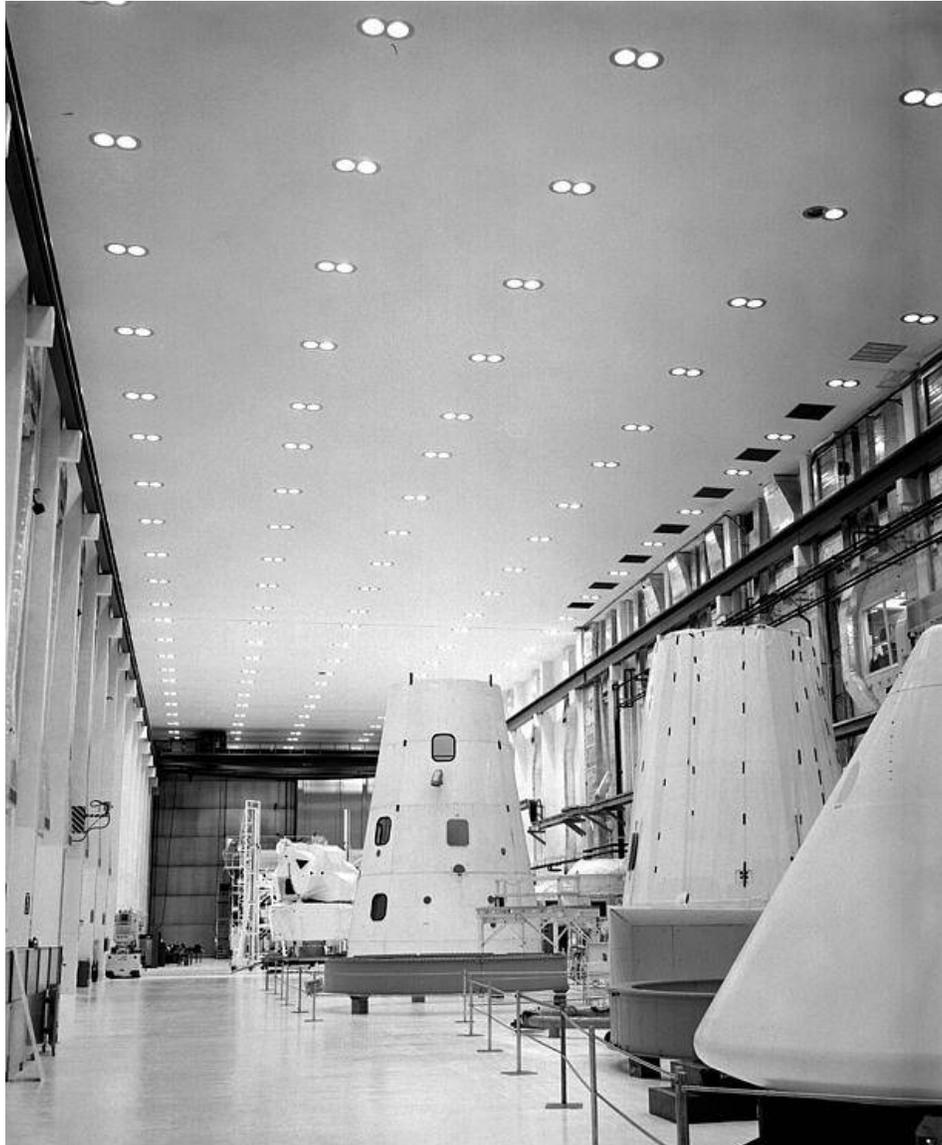
Figure B-13. Apollo spacecraft components within the Low Bay, facing west, March 1, 1968.
Source: John F. Kennedy Space Center Archives, 116-KSC-68-2629.

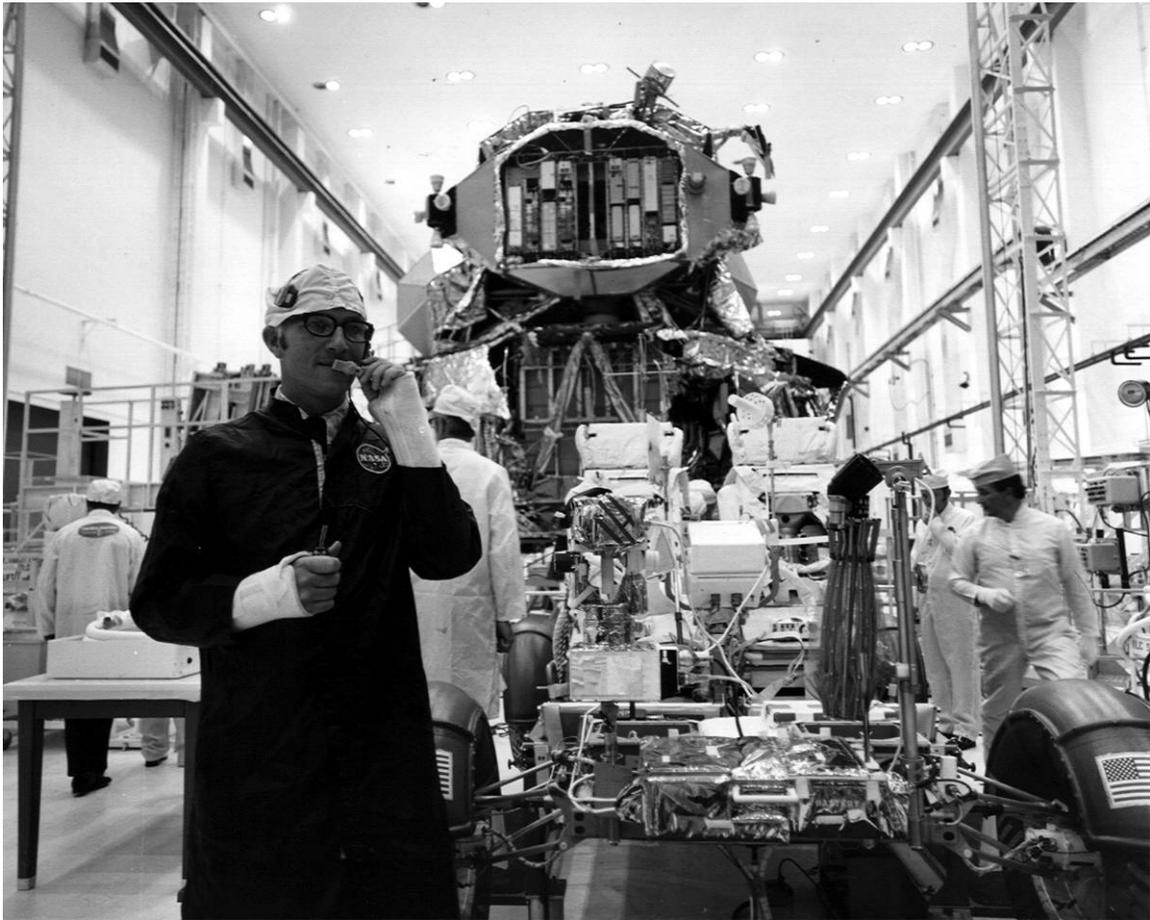
Figure B-14. Apollo 17 Lunar Rover Vehicle being readied for a test simulation in the Low Bay, direction unknown, August 4, 1972.

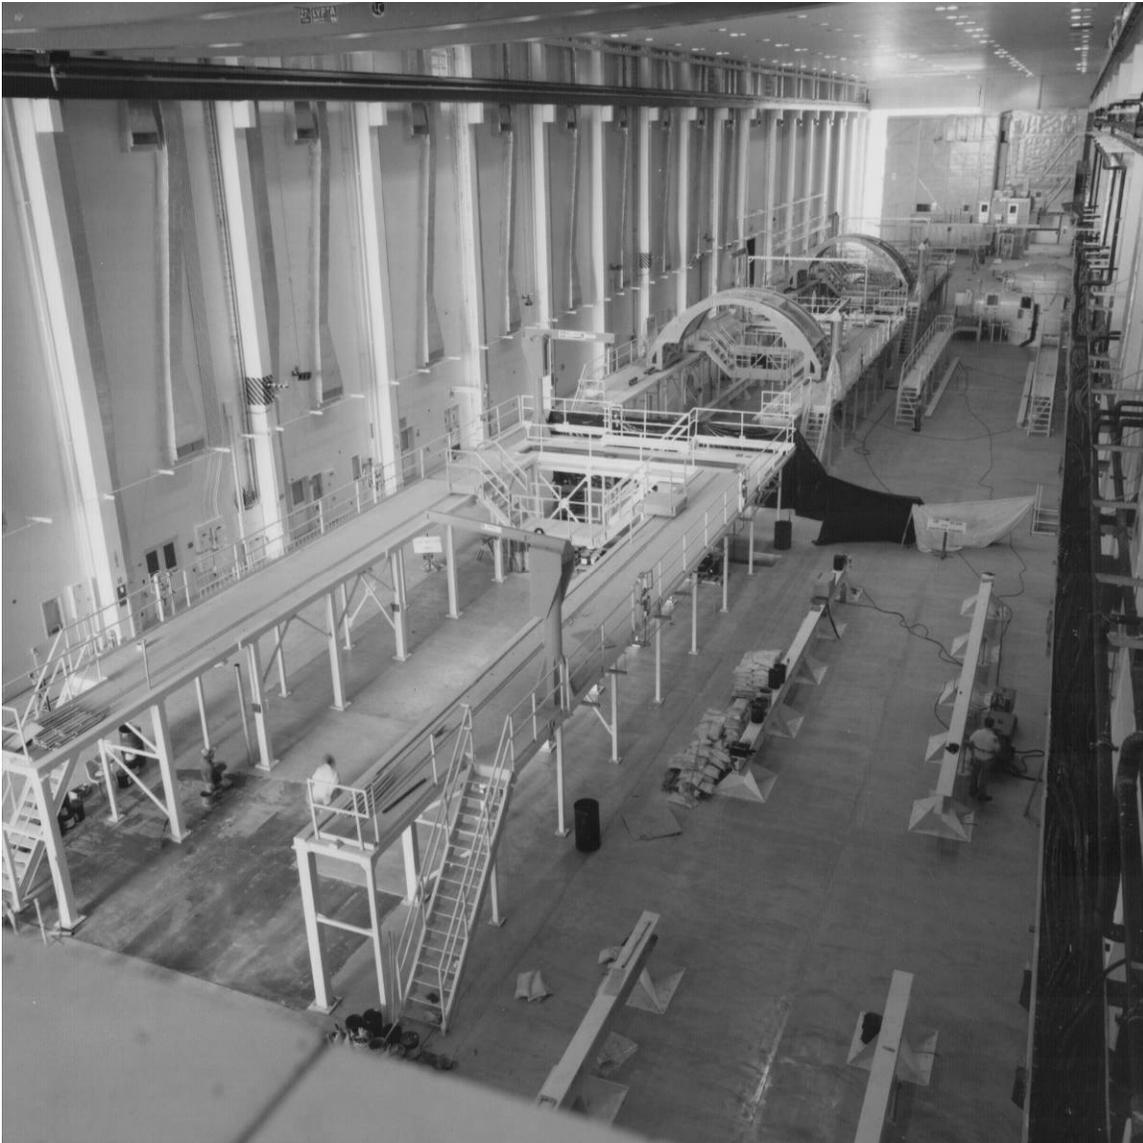
Figure B-16. Construction of the Spacelab workstands in the Low Bay, direction unknown,
May 31, 1978.

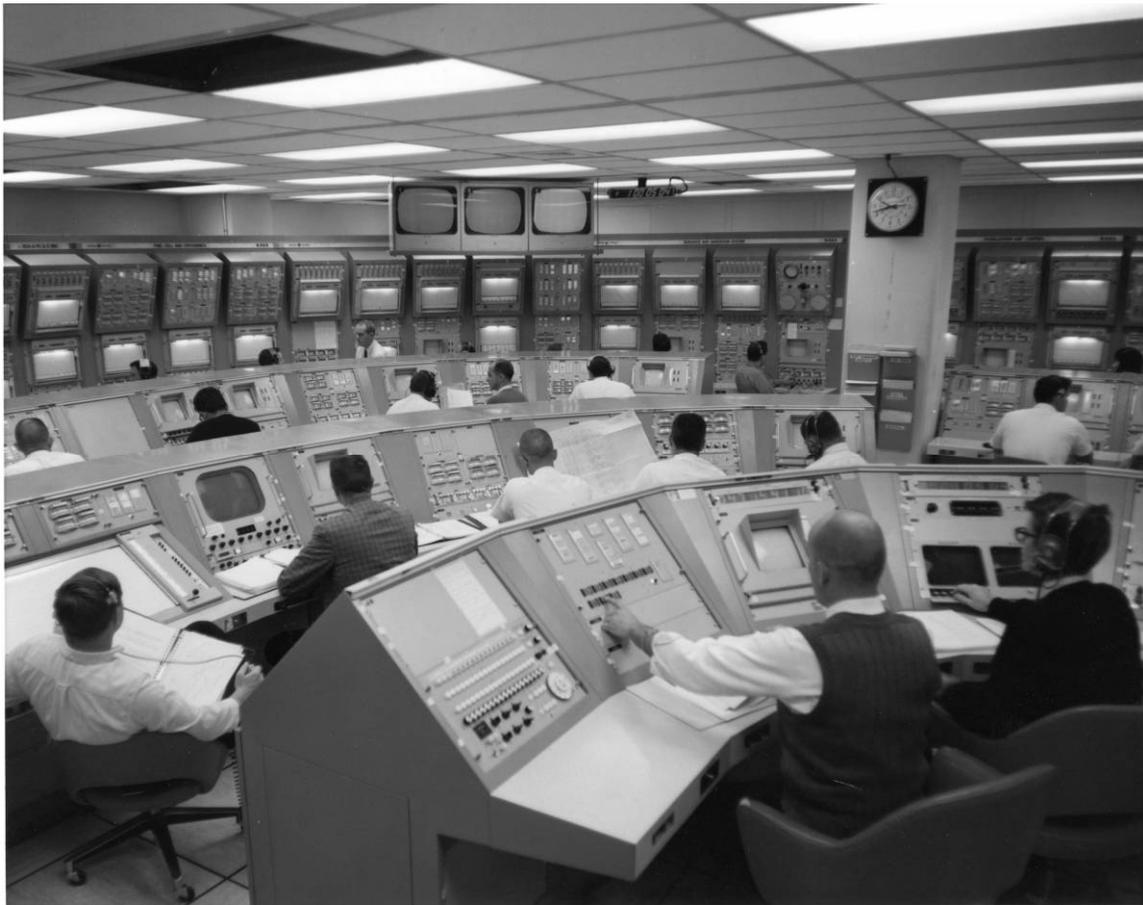
Figure B-17. View of Acceptance Checkout Equipment Station No. 1, direction unknown,
February 16, 1967.

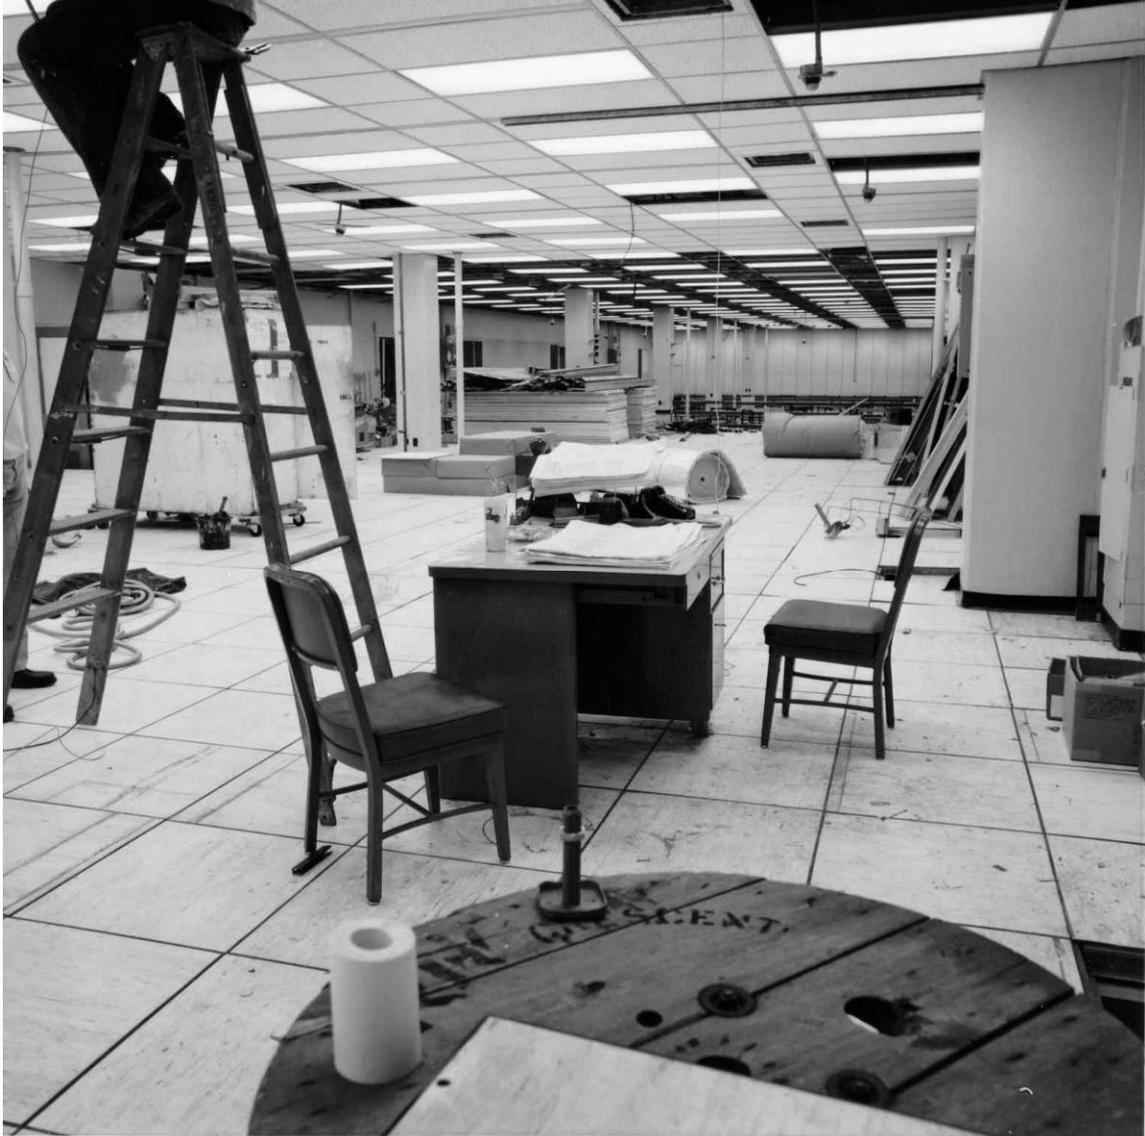
Figure B-18. Renovation of an Acceptance Checkout Equipment Station into Payload User Room Nos. A and B, direction unknown, April 28, 1981.

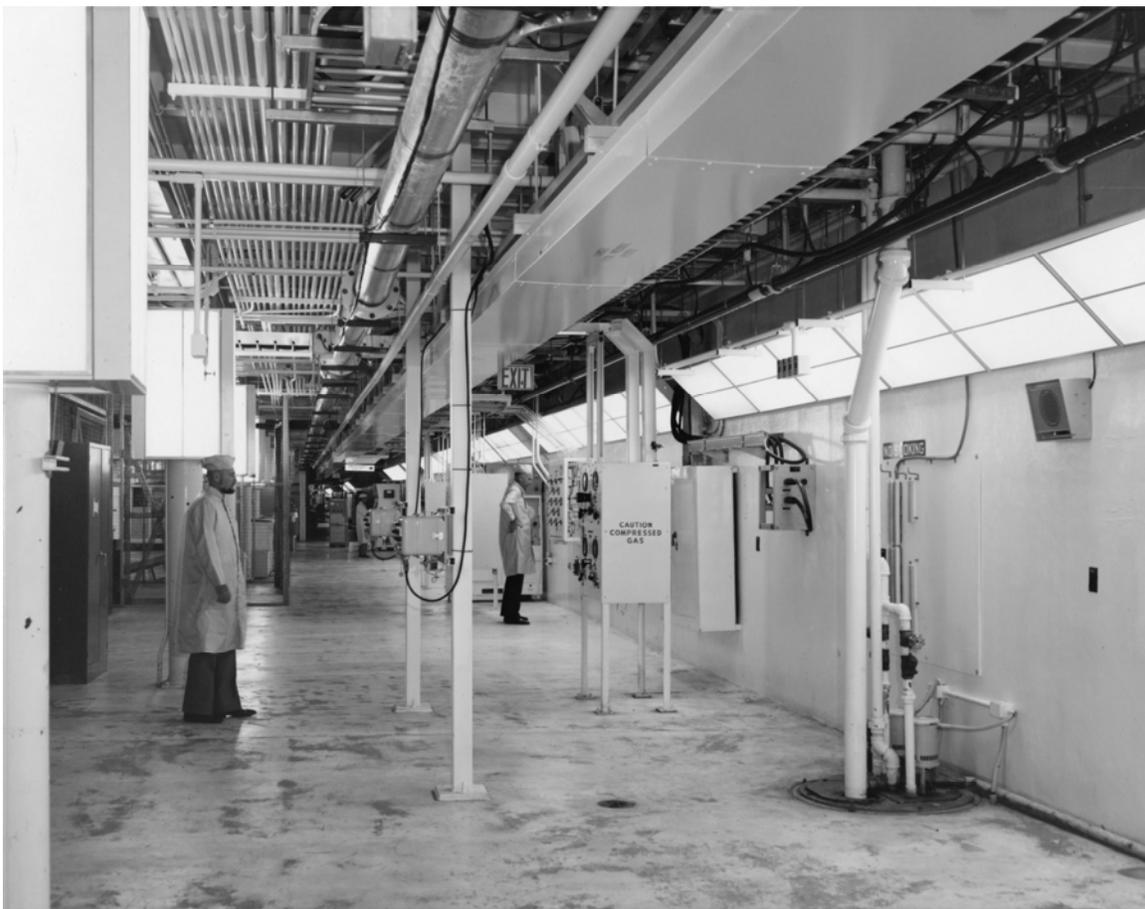
Figure B-27. View of the cable/utility tunnel, February 6, 1974.
Source: John F. Kennedy Space Center Archives, 108-KSC-74C-82.

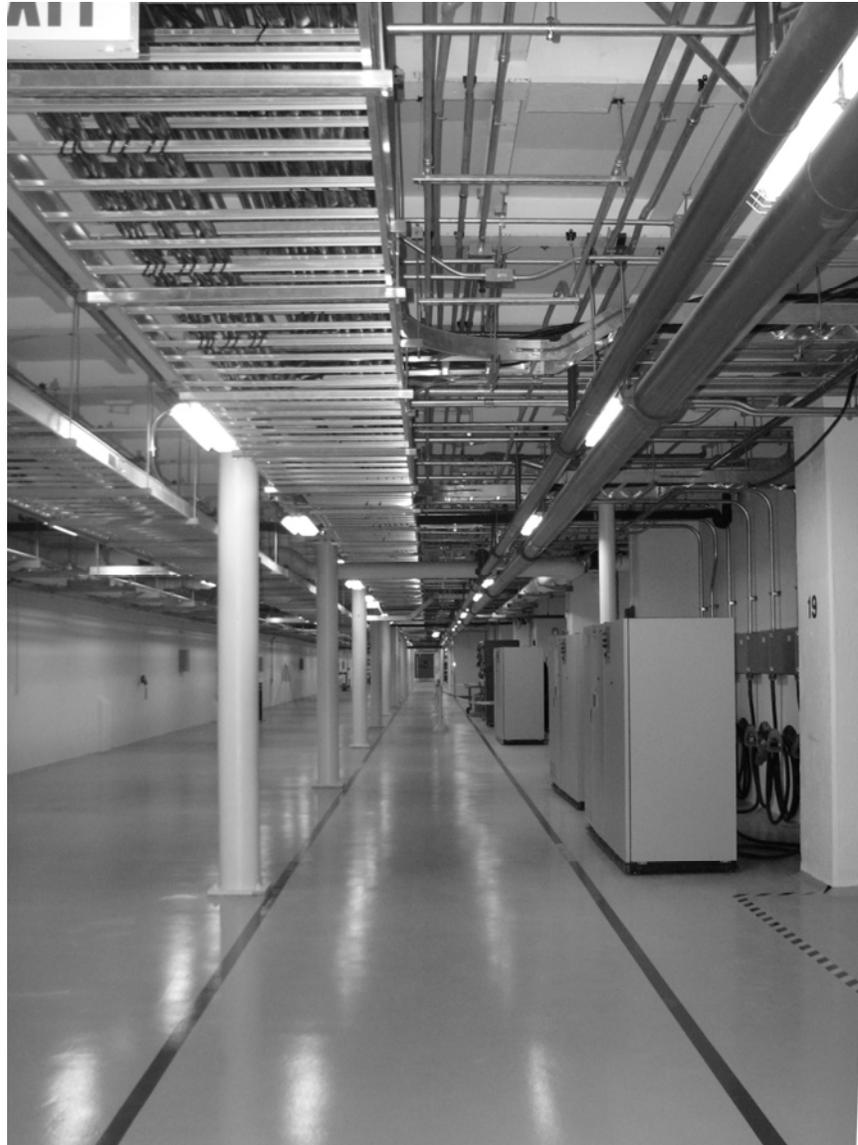
Figure B-28. View of the cable/utility tunnel, circa 2010.
Source: Lockheed Martin.

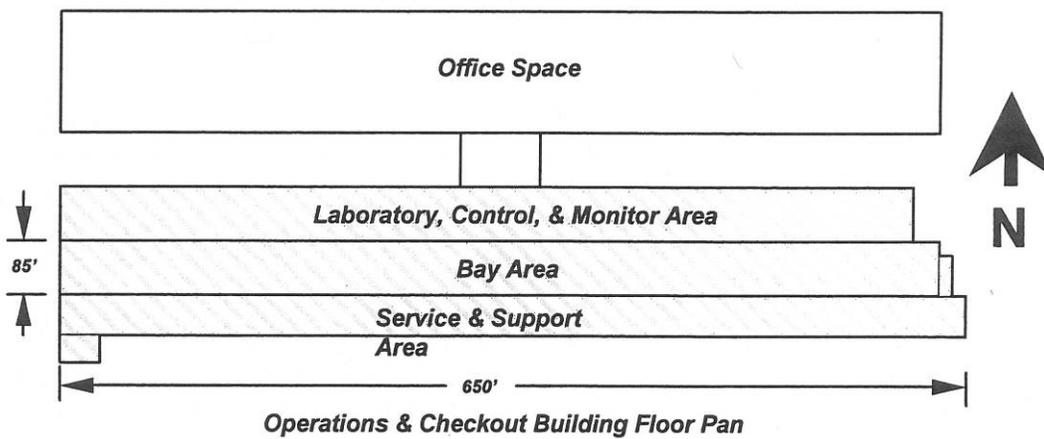
Figure B-29. General layout of the O&C Building, no date.
Source: John F. Kennedy Space Center Real Property Office, O&C Building.

4. Original plans and construction: The original plans for the O&C Building date to November 1962; construction occurred between January 1963, and November 1964. The original facility included north and south wings with a connector in between. In the north wing were administrative and engineering offices; the auditorium and cafeteria formed a connector between the north and south wings. The south wing included the laboratory and control room section to the north; a High Bay and Low Bay assembly and test area in the center; and the utility and service area along the south (Figure B-29).
