HISTORICAL STRUCTURE FORM

FLORIDA MASTER SITE FILE

Site Name(s) (address if none) Mate-Debate Device Multiple Listing (DHR only) _____
Survey Project Name HAER Documentation: Shuttle Landing Facility Survey # (DHR only) _____
National Register Category (please check one) building structure district site object
Ownership: private-profit private-nonprofit private-individual private-nonspecific city county state federal Native American foreign unknown

CONTINUATION SHEET**Narrative Description:**

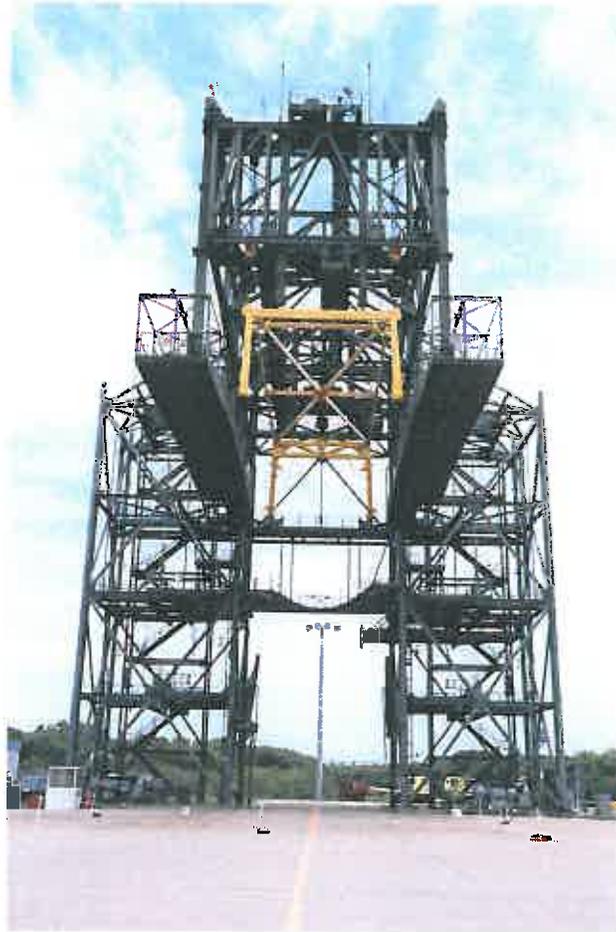
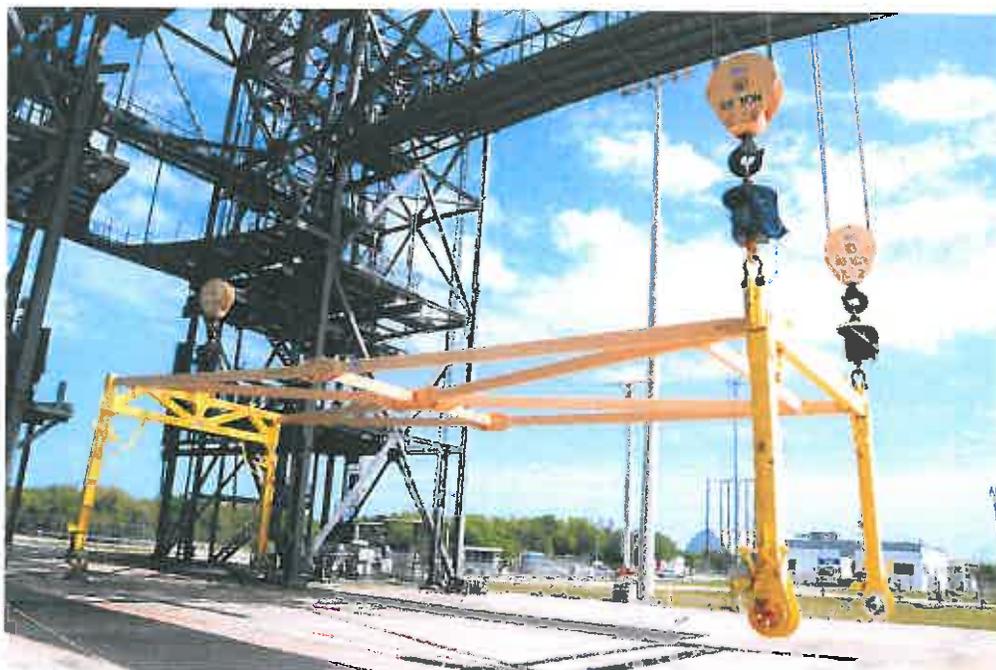
PHOTOGRAPHS

The Mate-Demate Device (MDD) is located at the northeast corner of the parking apron at the SLF. Its overall dimensions are 105 ft in length (east-west axis), 93 ft in width (north-south axis), and 105 ft in height. The open steel truss frame rests on a concrete base and utilizes open grating for the six deck levels, located at 4 ft, 20 ft, 40 ft, 60 ft, 80 ft, and 100 ft above grade. The MDD features two orbiter access arms, which can be raised and lowered within the first 60 ft. Between these arms is the orbiter sling back, which is connected to the orbiter in order to lift it with the use of three 50-ton hoists. There are also two sets of moveable platforms at 15-ft 7-in and 44 ft 3-in above grade. These are shaped around the orbiter's nose, and are hinged to raise and lower vertically. At the northeast and southeast corners are open-grate metal stairs, which extend from ground level to the highest deck. The original navigation equipment for the runway sat at the top of the MDD until early 2006.
