CAPE CANAVERAL AIR FORCE STATION,  
LAUNCH COMPLEX 39,  
PARACHUTE REFURBISHMENT FACILITY (PRF)  
(John F. Kennedy Space Center)  
Cape Canaveral  
Brevard County  
Florida

HAER FL-8-11-Q

HAER No. FL-8-11-Q

Report Prepared by: New South Associates, Stone Mountain, Georgia.

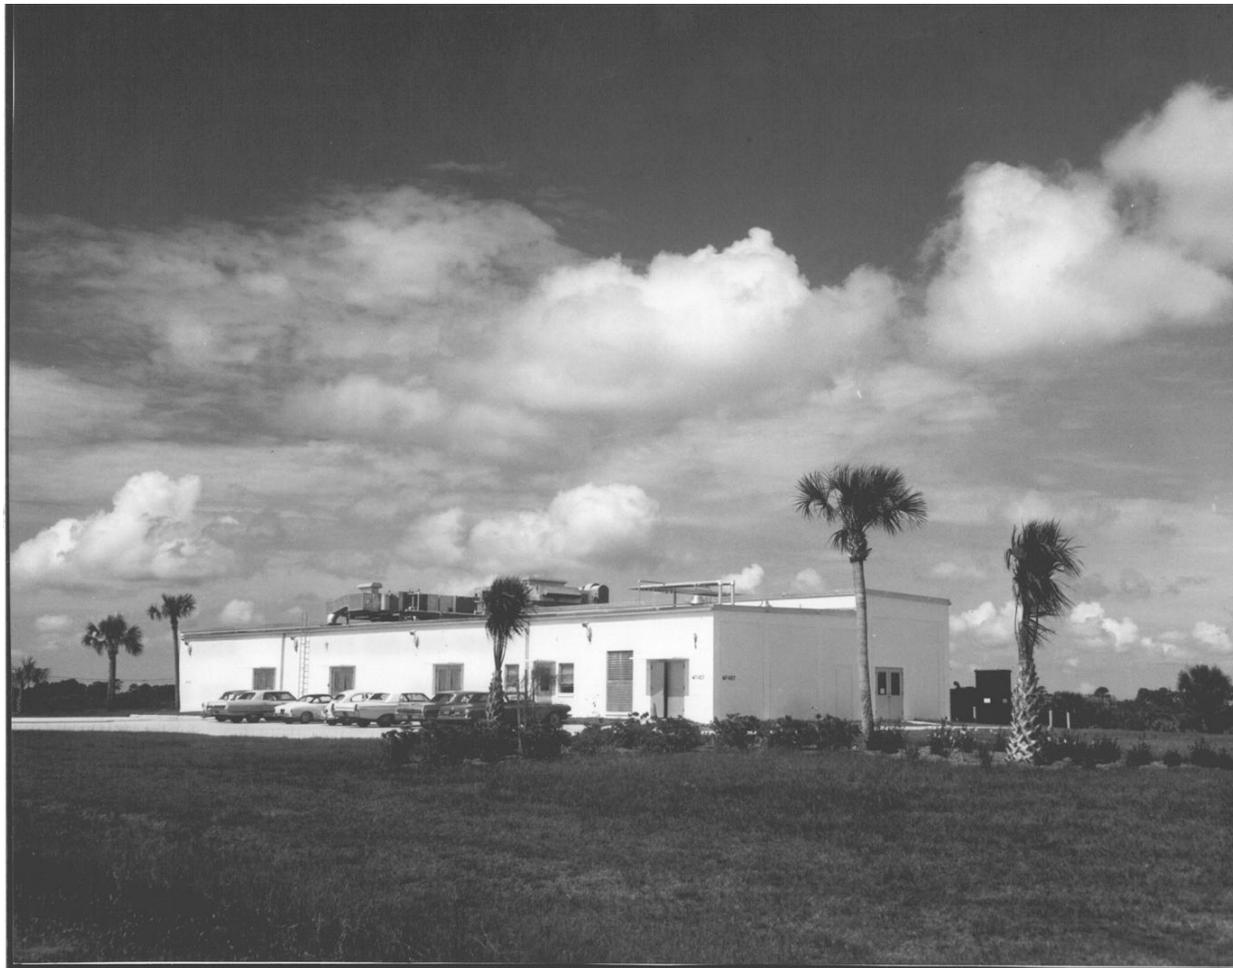
Photograph of the Original Parachute Refurbishment Facility Before Additions, View Southwest. (Source: KSC, Image 105-KSC-66C-5579).

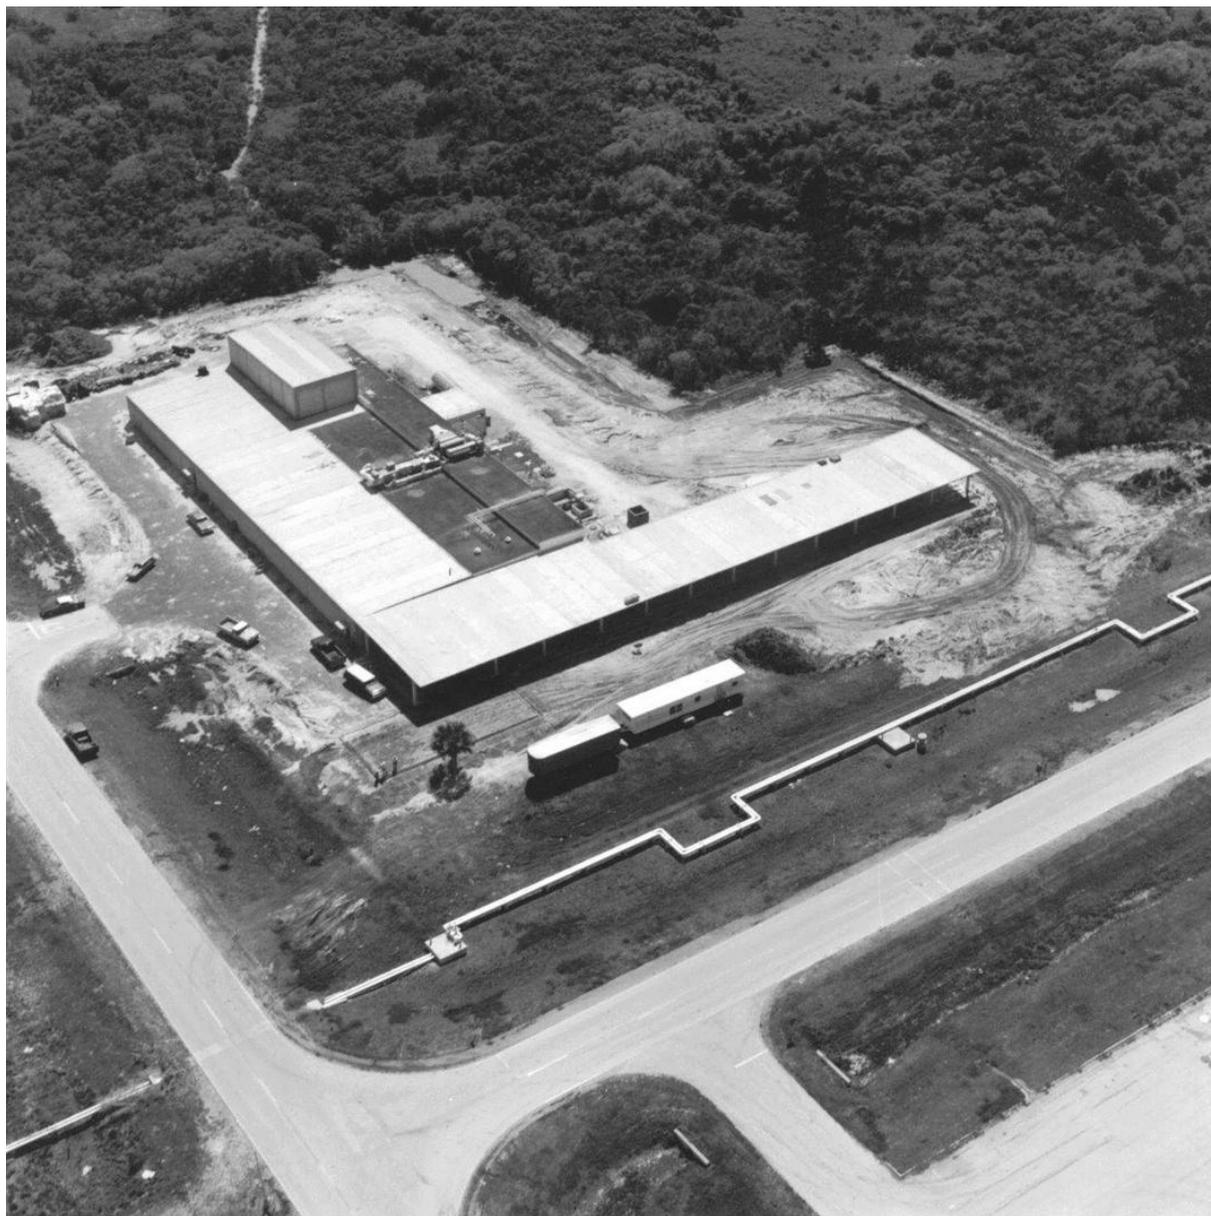
Aerial View of the Parachute Refurbishment Facility After Additions, View Southwest, 1978. (Source: KSC, Image 108-KSC-378C-201-1).

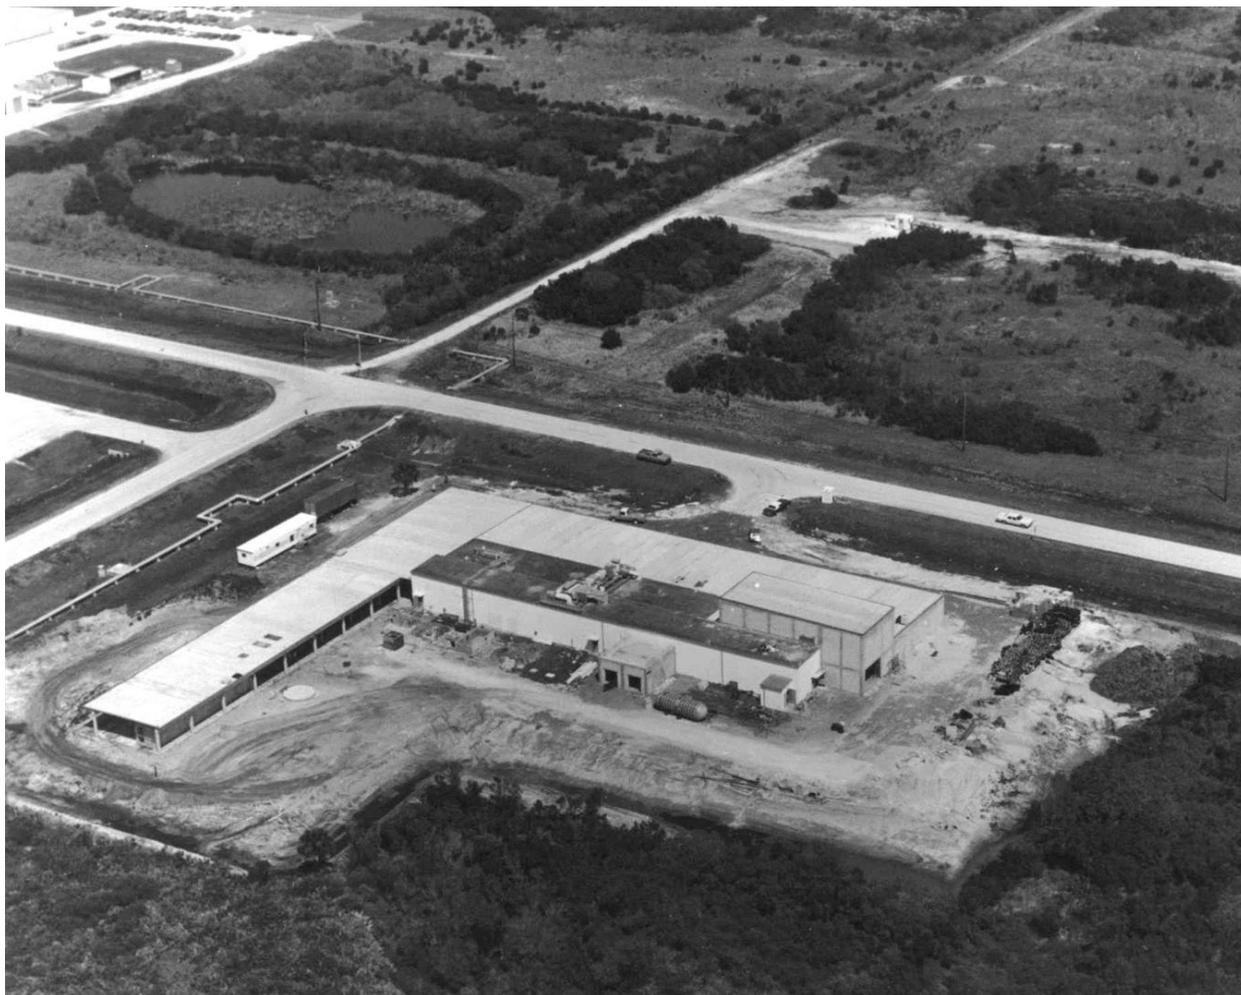
Aerial View of the Parachute Refurbishment Facility After Additions, View Northeast, 1978. (Source: KSC, Image 108-KSC-378C-202-6B).

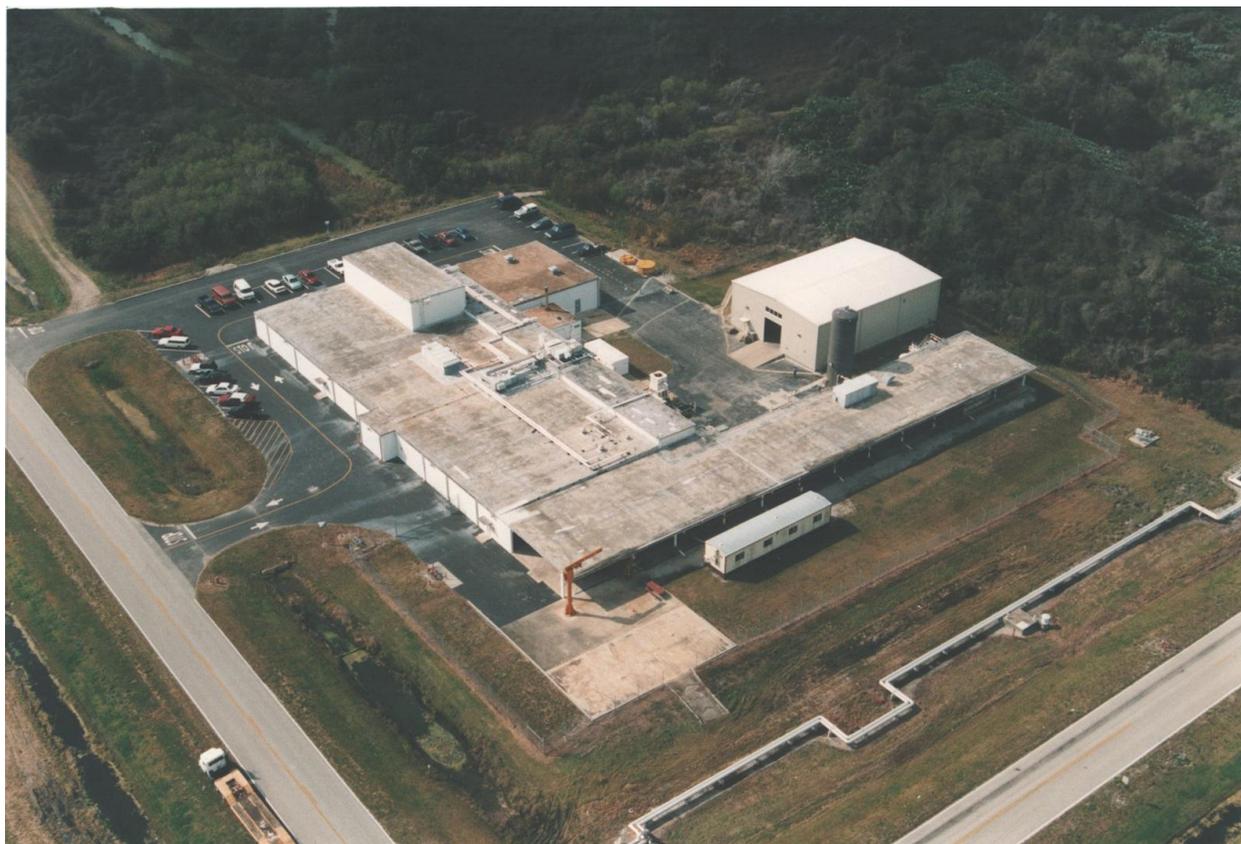
Aerial View Showing the Parachute Refurbishment Facility After Addition of Materials Testing Area and Warehouse, View Southwest, 1996. (Source: KSC Image KSC-396C-0958-35)
