## **Understanding the Source: A Critical Factor in Achieving Remedial Success**

# Understanding the Source: A Critical Factor in Achieving Remedial Success

Seventh International Conference on  
the Remediation of Chlorinated and  
Recalcitrant Compounds

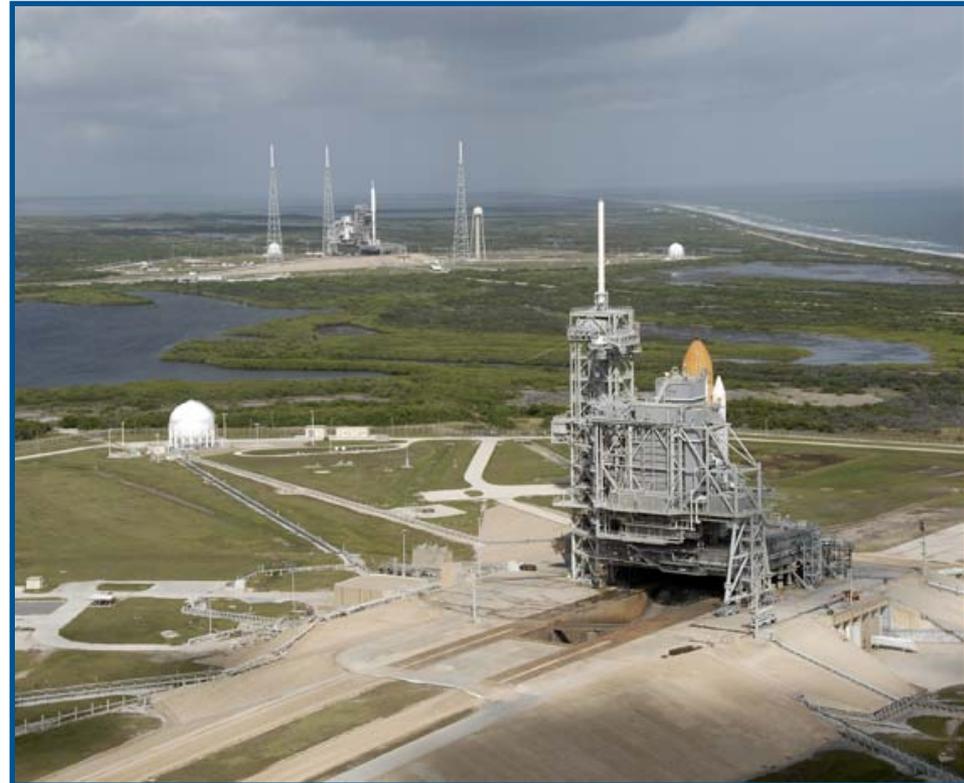
- NASA shuttle launch pad
- TCE, cDCE and VC identified in groundwater at concentrations exceeding MCLs
- LOX tank area
  - *Discharge pipes extend from LOX tank*
  - *Perimeter ditch discharges to the adjacent surface water bodies*

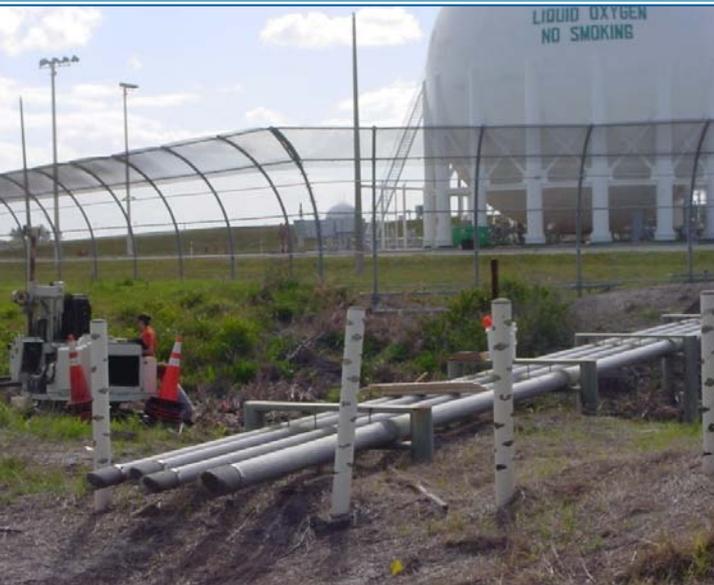
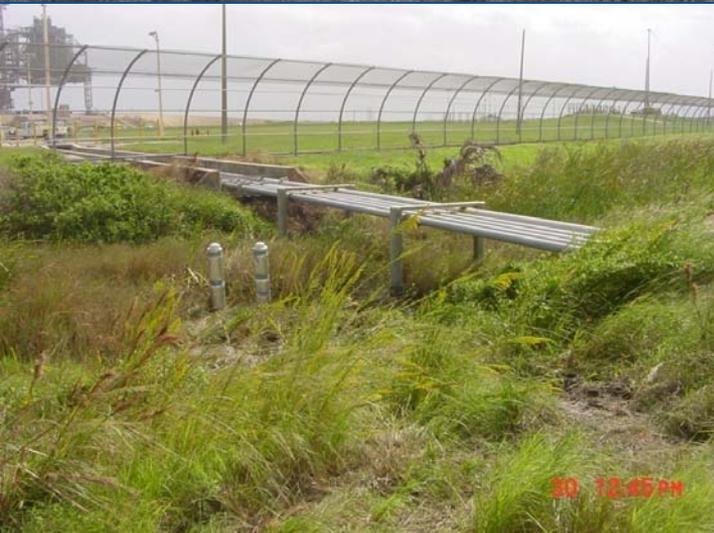
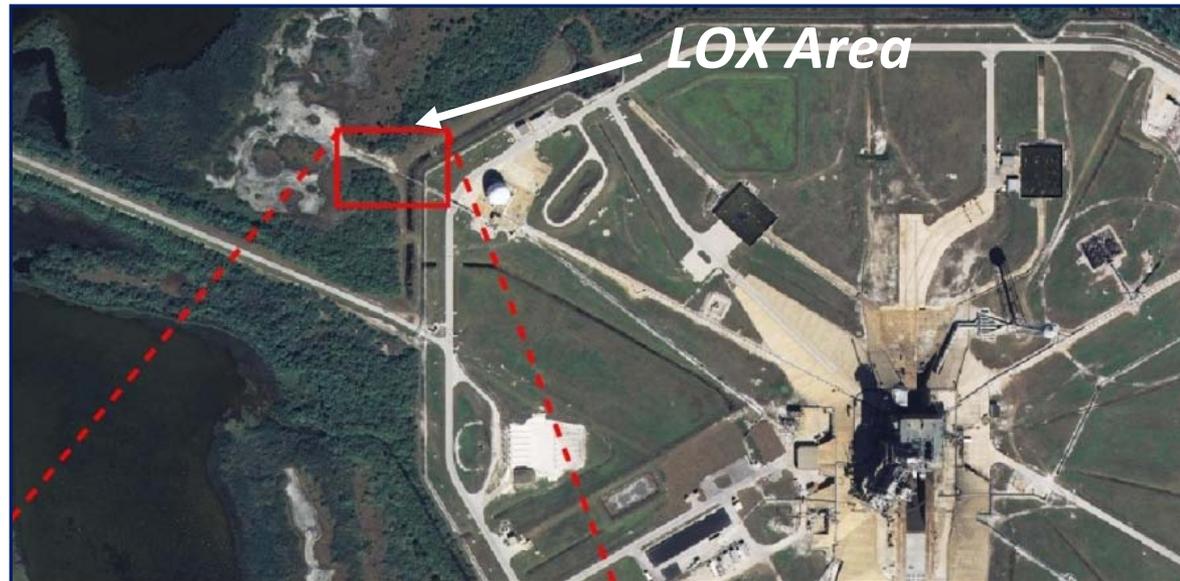
# LC39A Conceptual Site Model

- TCE release occurred at LOX pipe discharges
- Maximum VOC concentrations at LOX pipe discharge
- TCE plume w/ daughter products

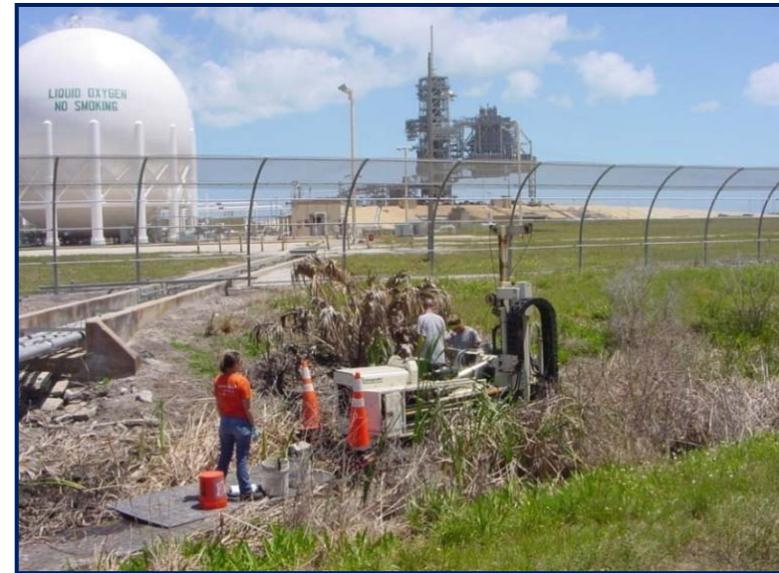
Sandy CLAY ditch lining

- Soil PID responses to >9,999 ppm
- Maximum saturated zone soil concentrations
  - TCE = 27,500 mg/kg
  - cDCE = 82.5 mg/kg
- Maximum groundwater TCE = 499,000 µg/L
- Mass focused from 1 to 5 ft below base of ditch
- Mass sorbed within clay layer
- Maximum soil concentrations indicative of TCE DNAPL

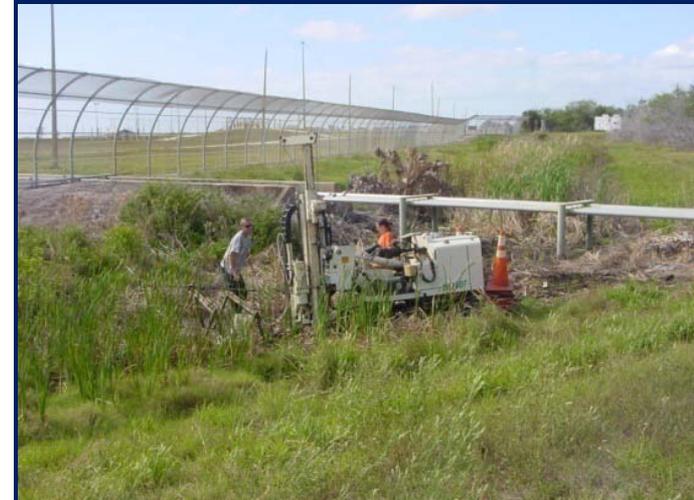
- 25 ft can make a big difference when it comes to source assessment!
  - *LOX pipes were extended in early 1970's ~25 ft*
  - *LOX pipe outfall historically was the ditch*
- Clay ditch lining provided mechanism for significant mass diffusion
- Source is shallow – excavate and enhance bioremediation in dissolved plume

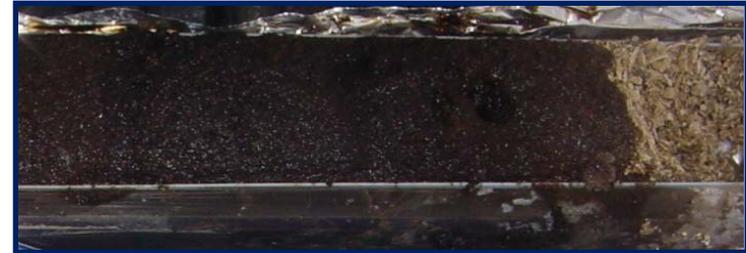
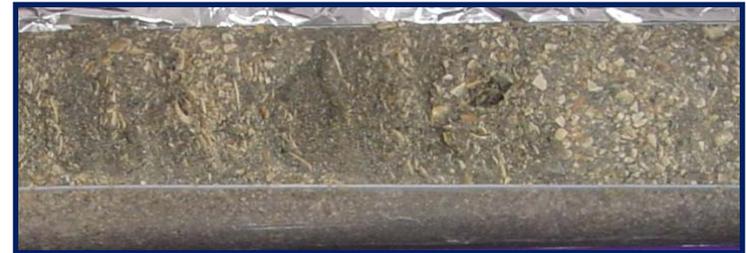
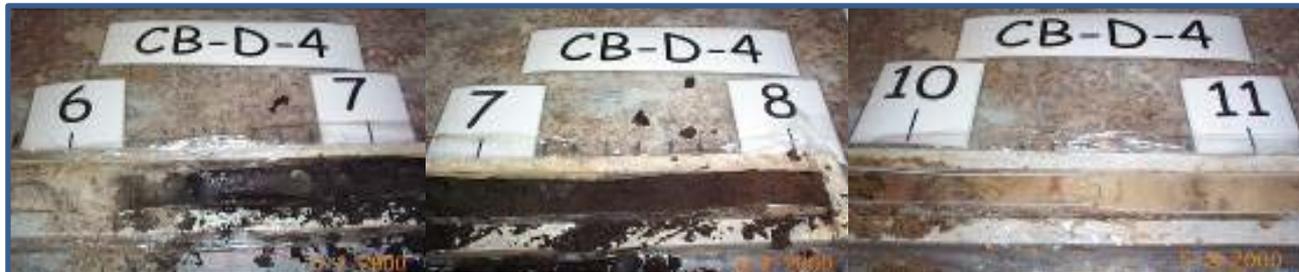
**Organic Interval**

- Lithology:
  - *Fine to medium sand from land surface to 4 to 8 ft bls*
  - *Dark brown to black organic/peat layer below the sand, 2 to 4 ft thick*
  - *Underlain by a tan shelly sand layer*

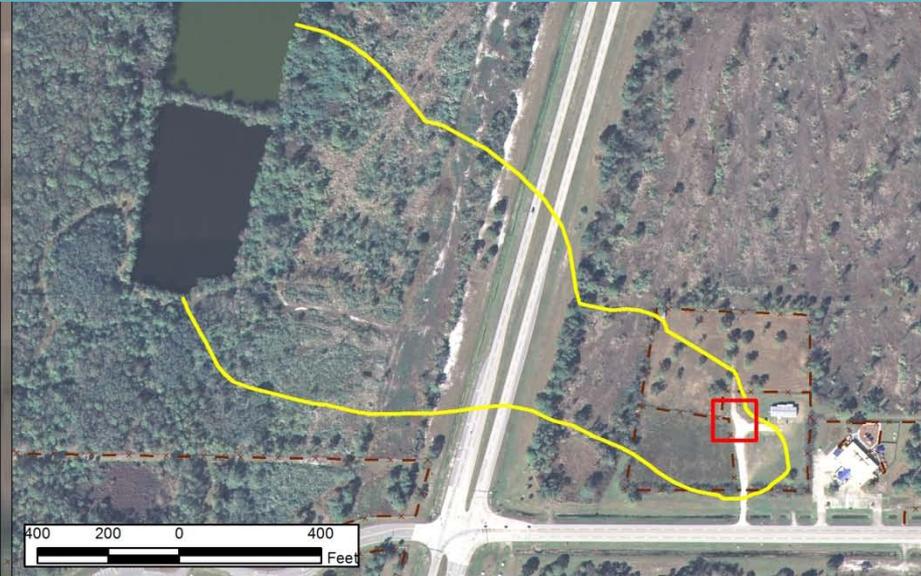
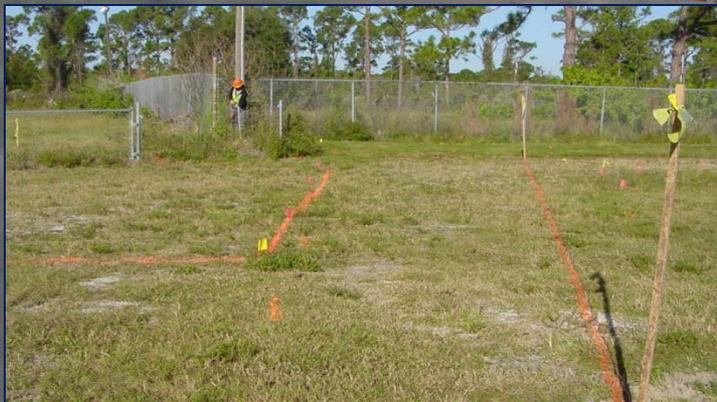
# Source Area Assessment Groundwater – PCE Contours

- 1,500 ft vinyl chloride plume emanating from shallow PCE source area of less than ¼ acre
- PCE only detected within shallow source area
- Dissolved plume transport in sands underlying organic zone
- Remediation of site would have been significantly hampered if source area was not identified
- Source removed via wet excavation

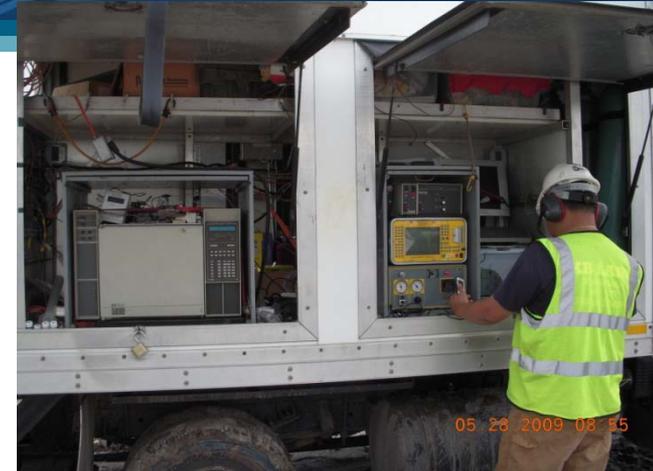
- 65 DPT sample locations
  - *Multiple Mobilizations beginning in 2006*
  - *265 samples collected for analysis*
  - *Utilized mobile laboratory and fixed-based laboratory*
- 21 Membrane Interface Probe (MIP) locations
  - *Continuous from surface to 50 feet bls*
- 14 additional monitoring wells
